# Embankment Failures on Soft Clay in Brazil

J.A. Ortigao

## Introduction

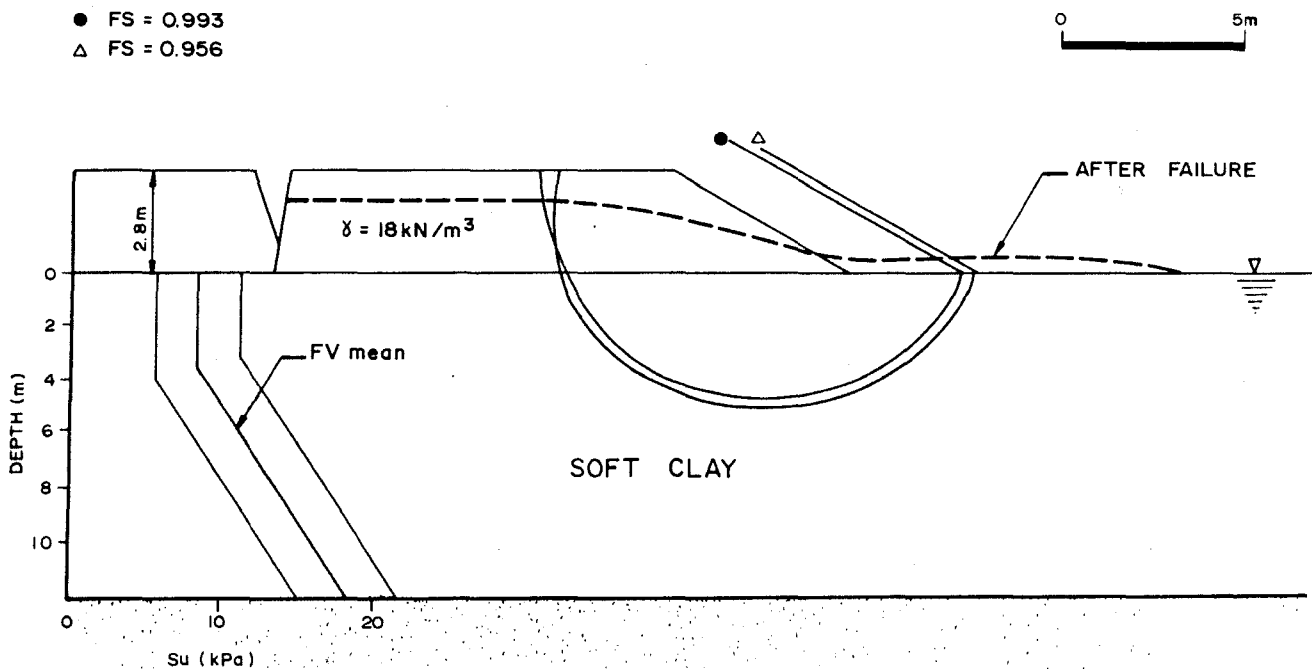
Figure 2 - Case 1 - Failure on Rio de Janeiro clay [6]

Case 1 - A full scale instrumented trial embankment was carried out at site 1 on Rio de Janeiro clay, in 1977 [6]. The ground consists of soft marine clay with liquid limit (*LL*) from 120% to 160%. The water content (*w*) ranges from 120 to 180%, the plastic limit (*PL*) from 60 to 80% and mean plasticity index (*PI*) of around 80%. The field vane (*FV*) shear strength  $s_u$  of the clay varies from 8 to 18 kPa, as shown in the profile in figure 2, the mean value being 10 kPa [5]. Table 1 summarizes these soil properties.

Figure 2 shows the geometry of the embankment just prior to failure. A stability analysis using uncorrected *FV* strength profile using Bishop's simplified method gave a factor of safety (*FS*) close to one, which closely matches the observed behaviour. Still, Bjerrum's [2] field vane correction factor for a clay showing  $IP=80\%$  is 1/1.6, which would result in a reduction of the strength to be used in analyses.

At the time of the trial, it was argued that the *FV* correction was not necessary. The reasons were: the high plasticity of the clay, marine origin, mineralogy and organic content of the clay. Additional experience was necessary to confirm this. Since then, additional case histories have been added to the Brazilian data base.

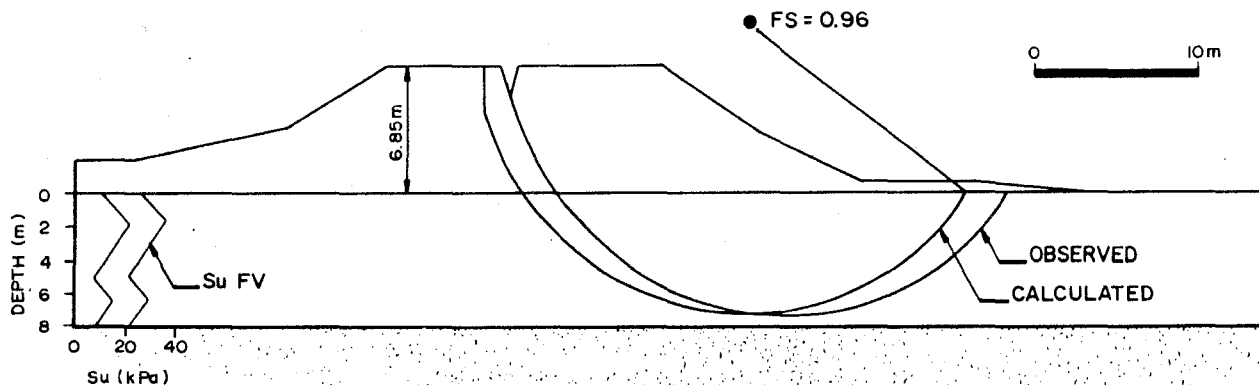
Figure 3 - Case 2 - Juturnaiba trial embankment [3]

Case 2 - Another full scale instrumented embankment failure was carried out at site 2, about 150 km north of Rio de Janeiro, at the site of Juturnaiba Dam [3]. The soft ground has 7m of interlayered soft alluvial organic clay and peat, with *PI* between 40 to 80% for the clay layers. Mean *FV* strength value was 20 kPa, but data showed considerable scatter and its was difficult to select a design

Figure 3 shows the embankment cross section. The embankment failed when its height reached 6.85m. A total stress stability analysis employing the uncorrected mean strength profile and considering cracking in the embankment material (ie, reduced embankment strength) yielded a factor of safety of 0.96, closely matching the observed behaviour (table 1).

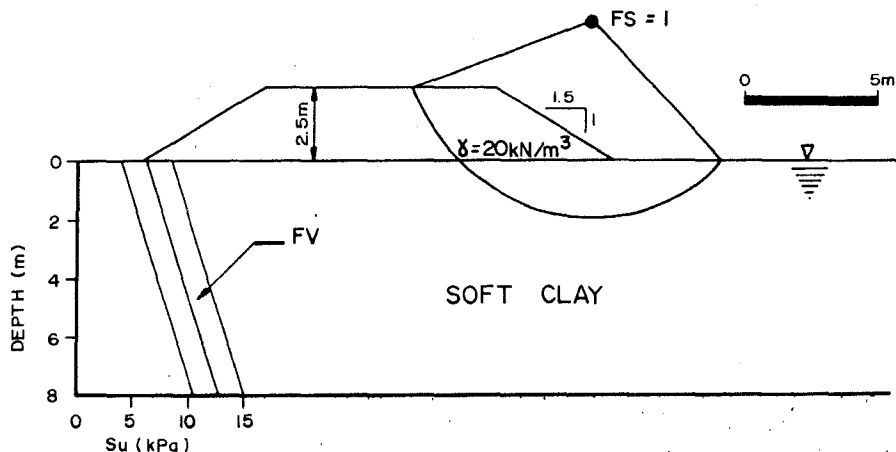
Figure 4 - Case 3 - Railway embankment failure near Sao Luis

Case 3 - Unlike the previous trials, this case was an accidental failure. It took place on a railway embankment that crossed a 20km length of marshy area near the city of Sao Luis. The

embankment design was based on *FV* strength data obtained from 100m spaced boreholes along the proposed railway alignment. But, failure took place on a softer marine design stage (figure 4).

Again, the stability analysis based on detailed site investigation yielded  $PI=50\%$ ,  $LL=90\%$  and  $w=70$  to  $110\%$  and a factor of safety close to 1 for failure conditions and mean uncorrected *FV* profile (table 1).

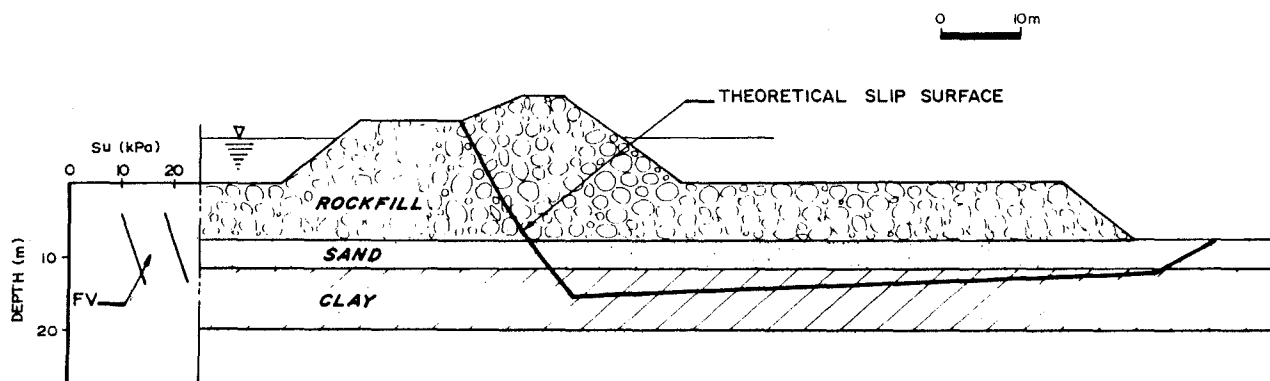
Figure 5 - Case 4 - Failure of a breakwater on soft soil

Case 4 - An end-of-construction failure of a breakwater took place on a soft clay foundation at site 4 (figure 1). The foundation soils consisted of a 4m layer

of fine sand, followed by 8 m of soft clay with *FV* strength ranging from 10 to 20 tkPa. Figure 5 shows a cross section of the breakwater. Post-failure stability analysis used Janbu's simplified method, polynomial slip surfaces and detailed site investigation. Uncorrected *FV* strength data yielded  $FS=0.98$  (table 1).
