Foundation Failure

Rare Foundation Failure of a Building in Shanghai, China

Dr. N. Subramanian, Consulting Engineer, Gaithersburg, Maryland, USA

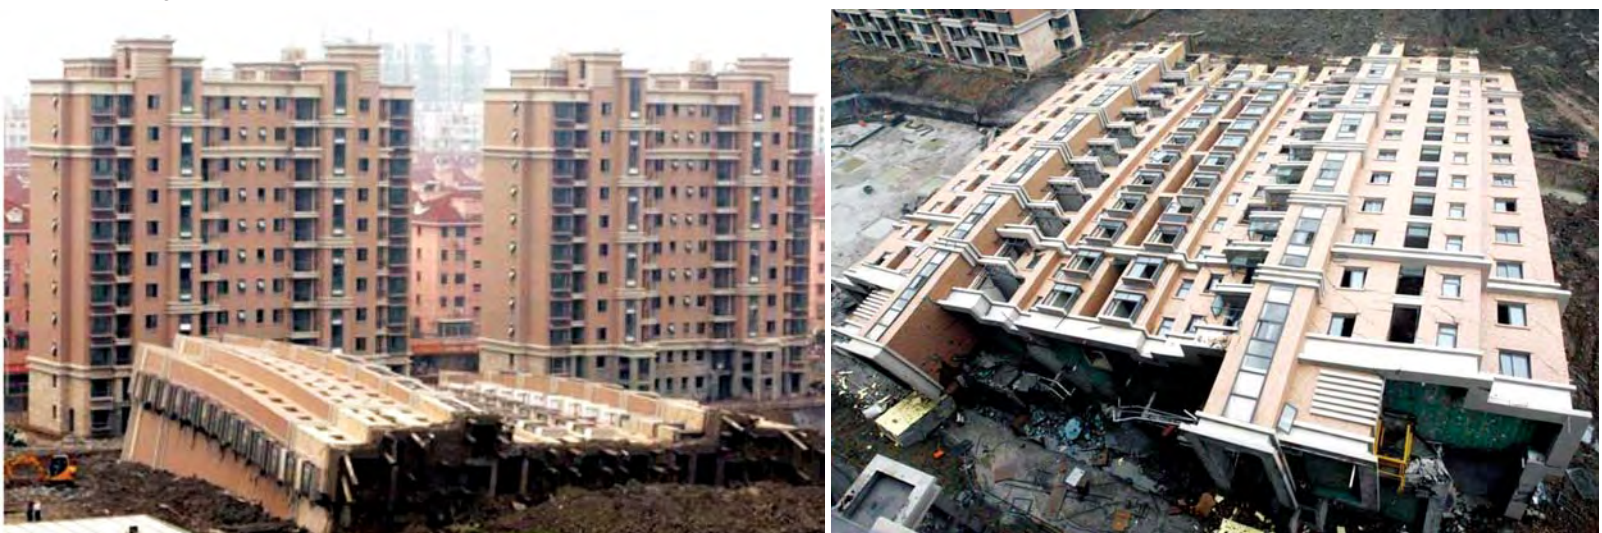
At around 5:30am on June 27, 2009, an unoccupied 13-storey block of flat building, still under construction, at Lianhuanan Road in the Minhang district of Shanghai city toppled over and ended up lying on its side in a muddy construction field (see Fig.1). One worker was killed. The official Xinhua News Agency said that a 28-year-old worker, surnamed Xiao, had gone into the building to get his tools and tried to jump out the window when the building fell. He was from Anhui province in eastern China.

Construction work on the block appeared to have been nearly completed, with windows fitted and a tiled facade. Other identical blocks in the same property development were still standing nearby (see Fig.1).

Figure 1: Two views of a toppled 13-storey apartment building that buried one worker in Shanghai on 27th June 09. Photo: Reuters

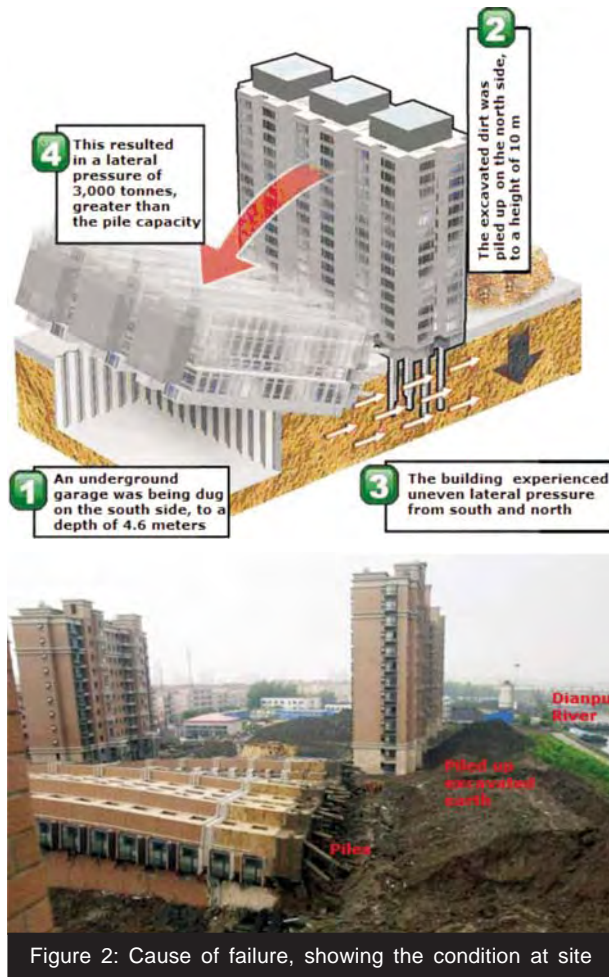
The report said the collapse was caused by earth, excavated along the building on one side with a depth of 4.6 m, for an underground car park, and piled up to depths of up to 10 m on the other side of the structure (see Fig. 2). The weight of overburden earth created a pressure differential, which led to a shift in the soil structure, eventually weakening the foundations and causing them to fail. This situation might have been aggravated by several days of heavy rain leading up to the collapse, but investigators did not site this as a crucial factor. The report said the construction company - Shanghai Zhongxin Construction did not anticipate that

From these investigations, it may be concluded that the failure was due to the following causes (see Fig.2):

- ◆ An excavation for underground garage was made on the south side, to a depth of 4.6 m, without any support for the earth walls.
- ◆ The excavated earth was piled up on the north side, to a height of 10 m.

Figure 2: Cause of failure, showing the condition at site

- ◆ The building experienced uneven lateral pressure from south and north. This was due to the overburden pressure and erosion of soil in the pit adjacent to the building, as a result of heavy rain.
- ◆ This resulted in a lateral pressure of 3,000 tonnes, which was

greater than the capacity of the concrete piles. Thus the building toppled over in the southerly direction.

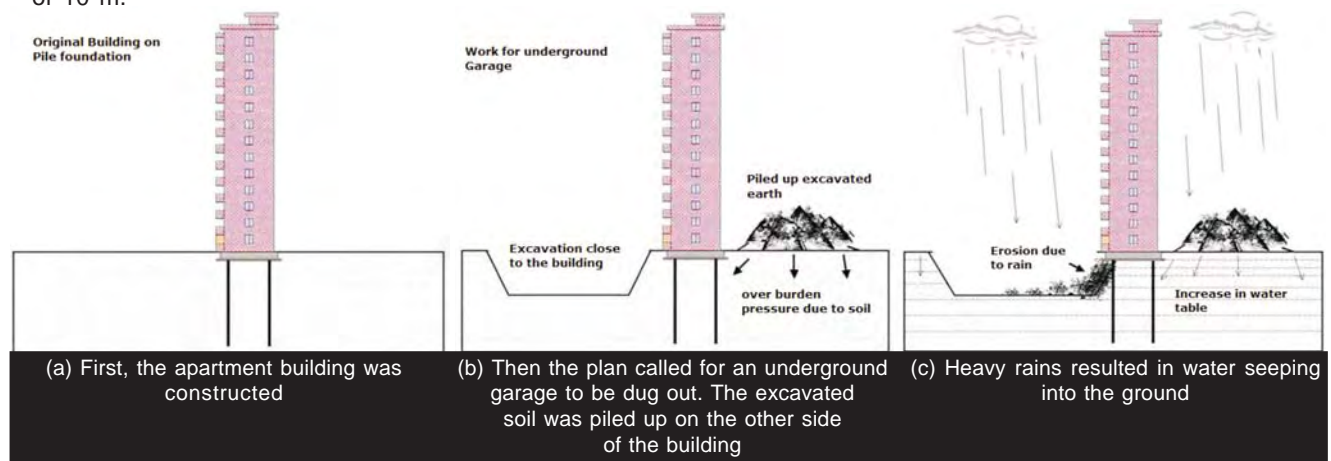
The sequence of failure of the building is shown in Fig. 3 and some more views of the failure in Fig. 4. Concern on constructed facilities in China^{14,15}
