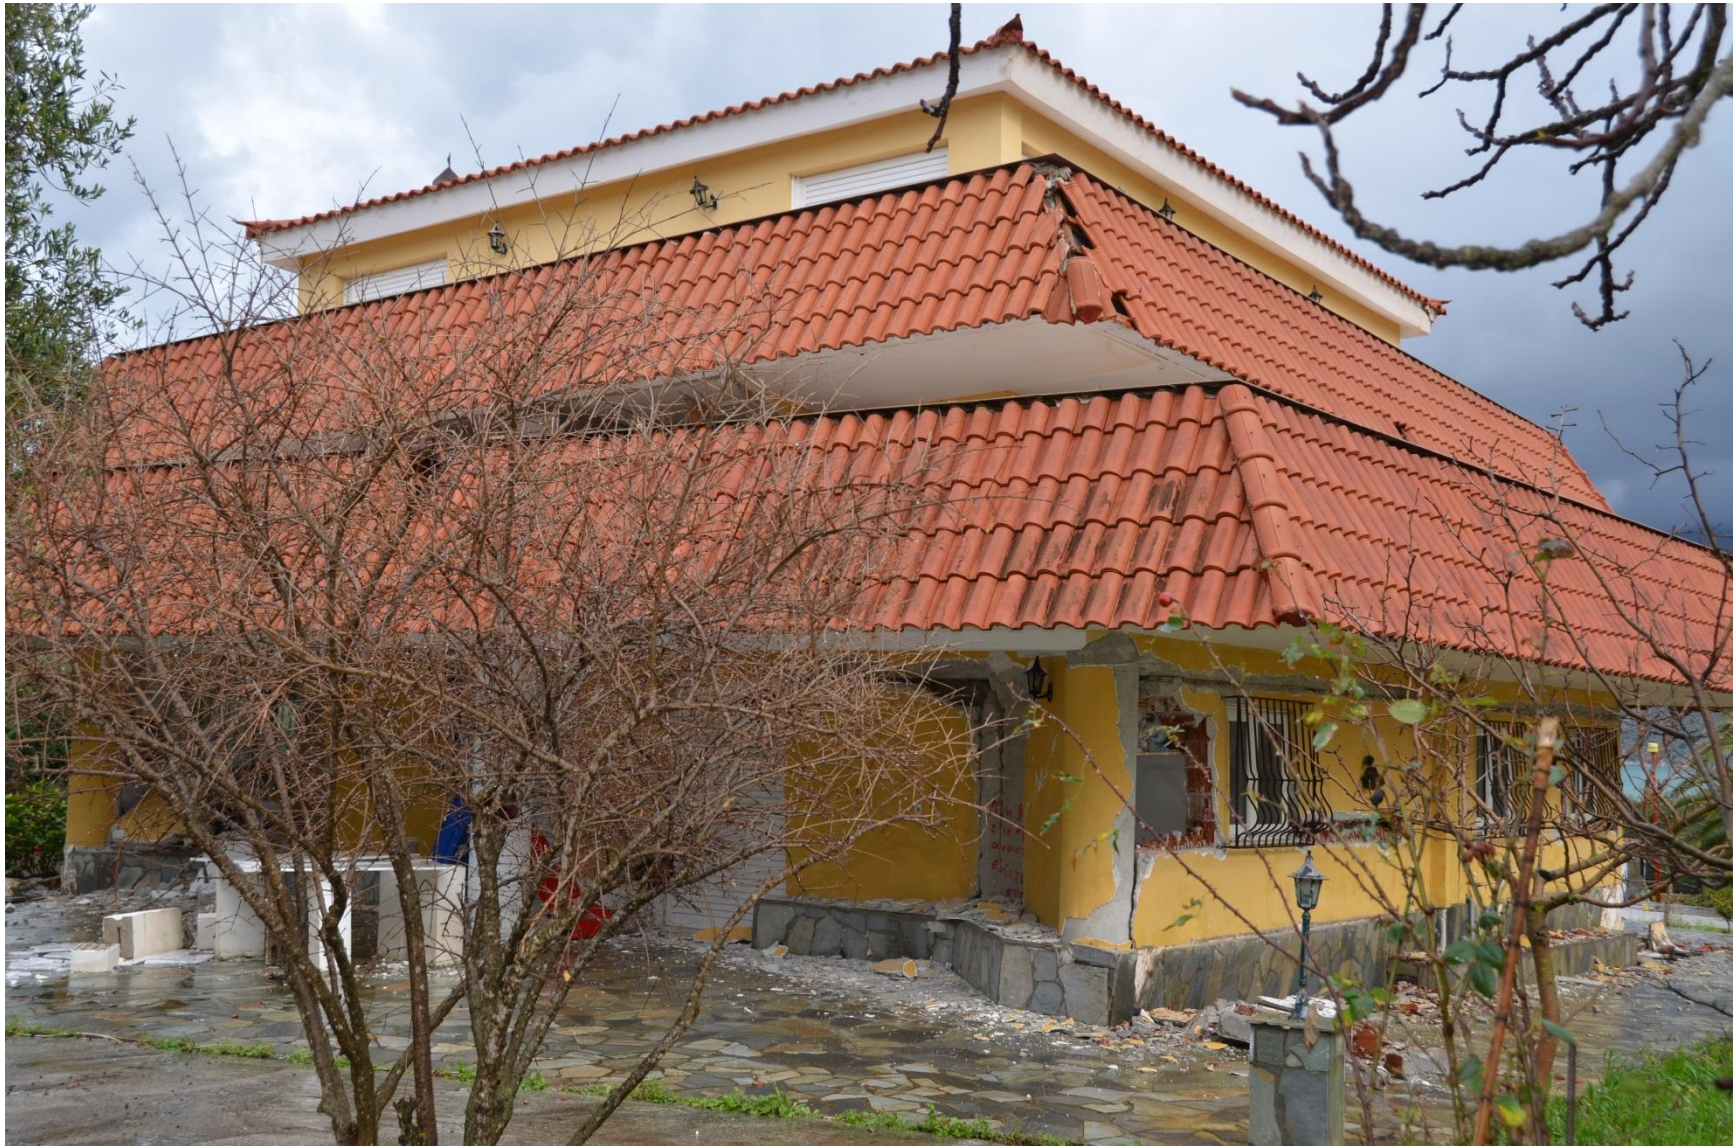
**Photo 1.** Total collapse of the second floor of a three-story RC building at Leivadi. The building had a 'pagoda' shape with reduced plan dimensions from floor to floor (the perimeter columns of each floor were not continuing to the upper floor).

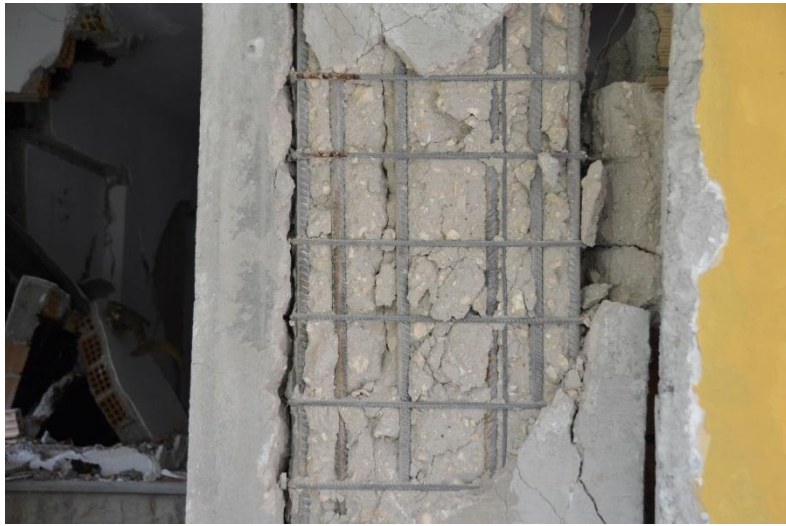
(a)

**Photo 2.** Damage to columns of the ground floor of the building of Photo 1: **(a)** limited damage after the first earthquake of Jan. 26; **(b)** extensive damage after the second earthquake of Feb. 3.

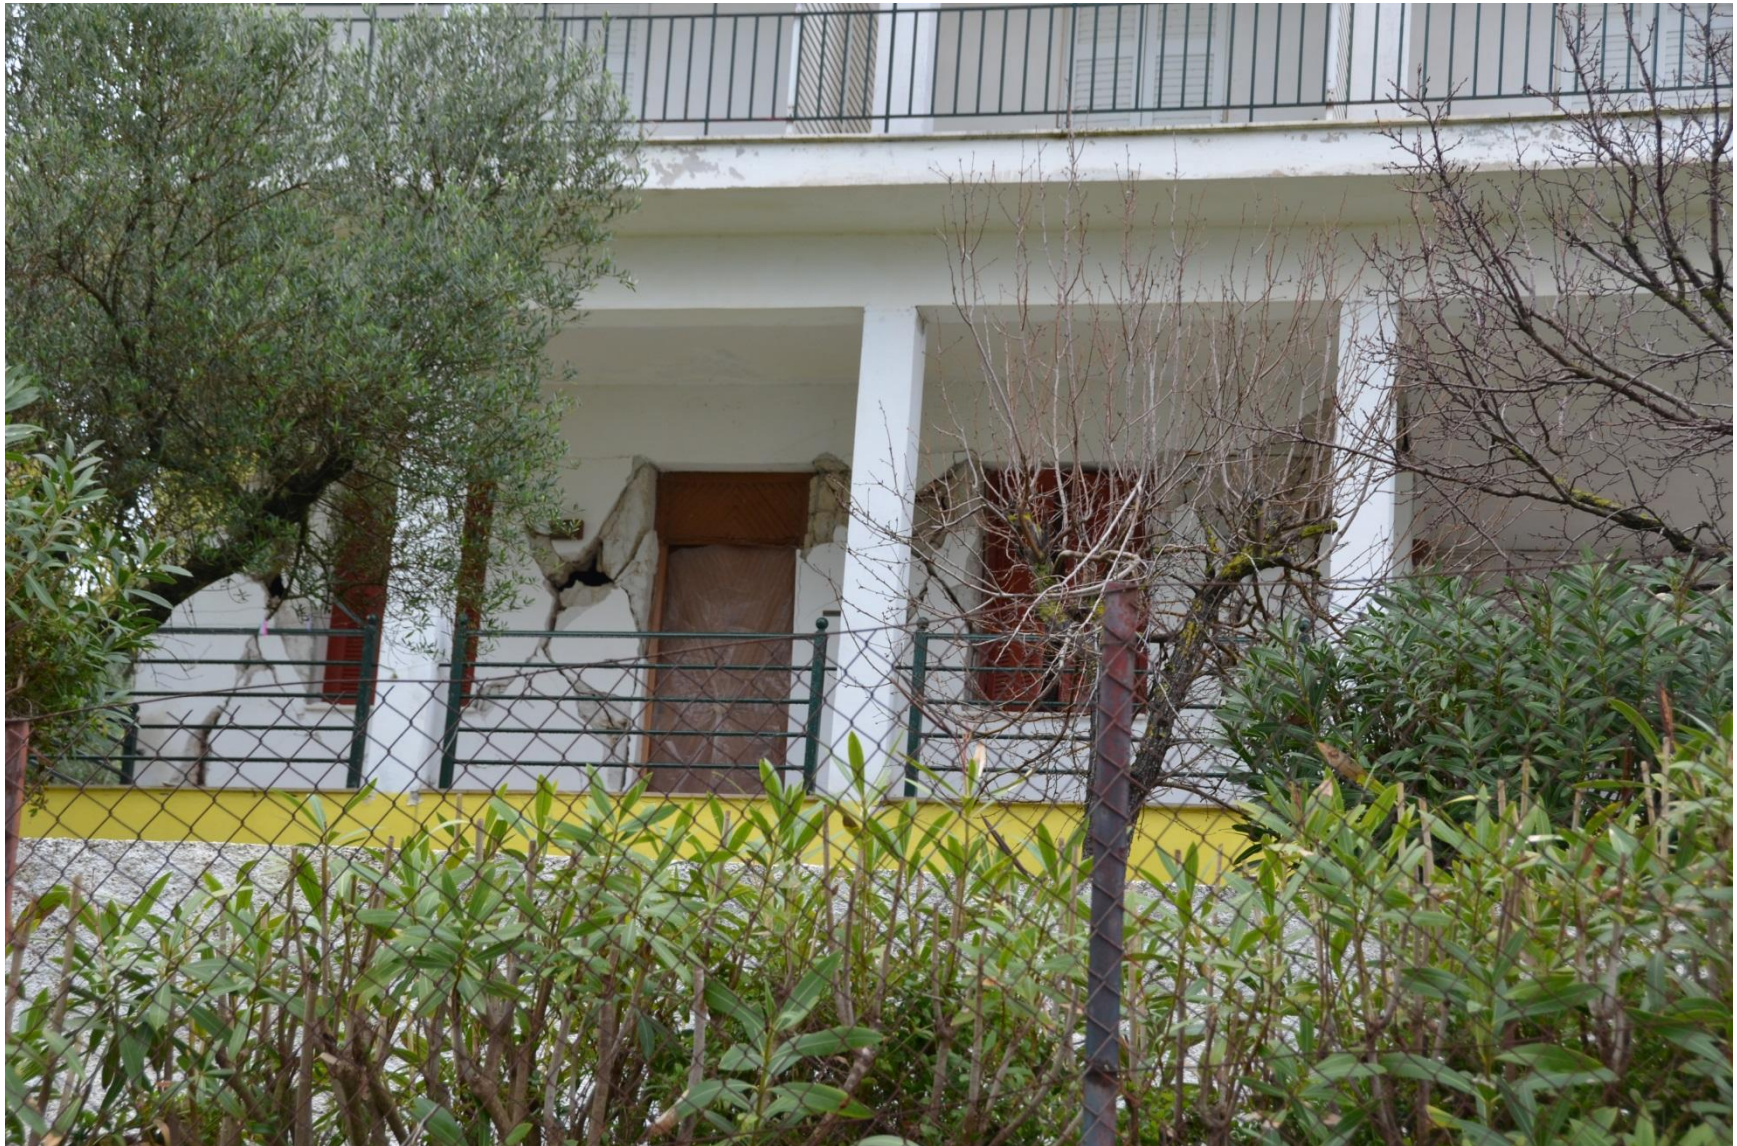
**Photo 3.** Damaged two-story building at Agios Dimitrios after the first earthquake of Jan. 26. Here shown is extensive damage to brick infill walls. The building suffered limited damage to the RC columns, too (**Photo 4**).

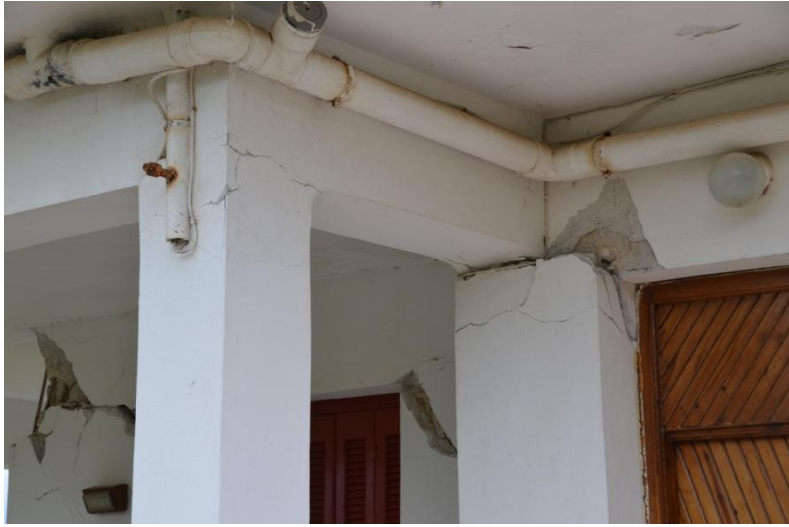
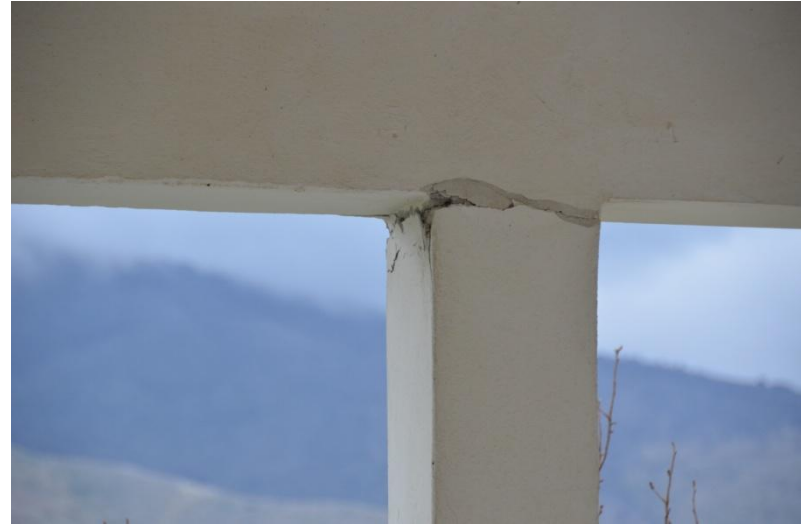
**Photo 4.** Damage to column-beam joints of the building of **Photo 3**.

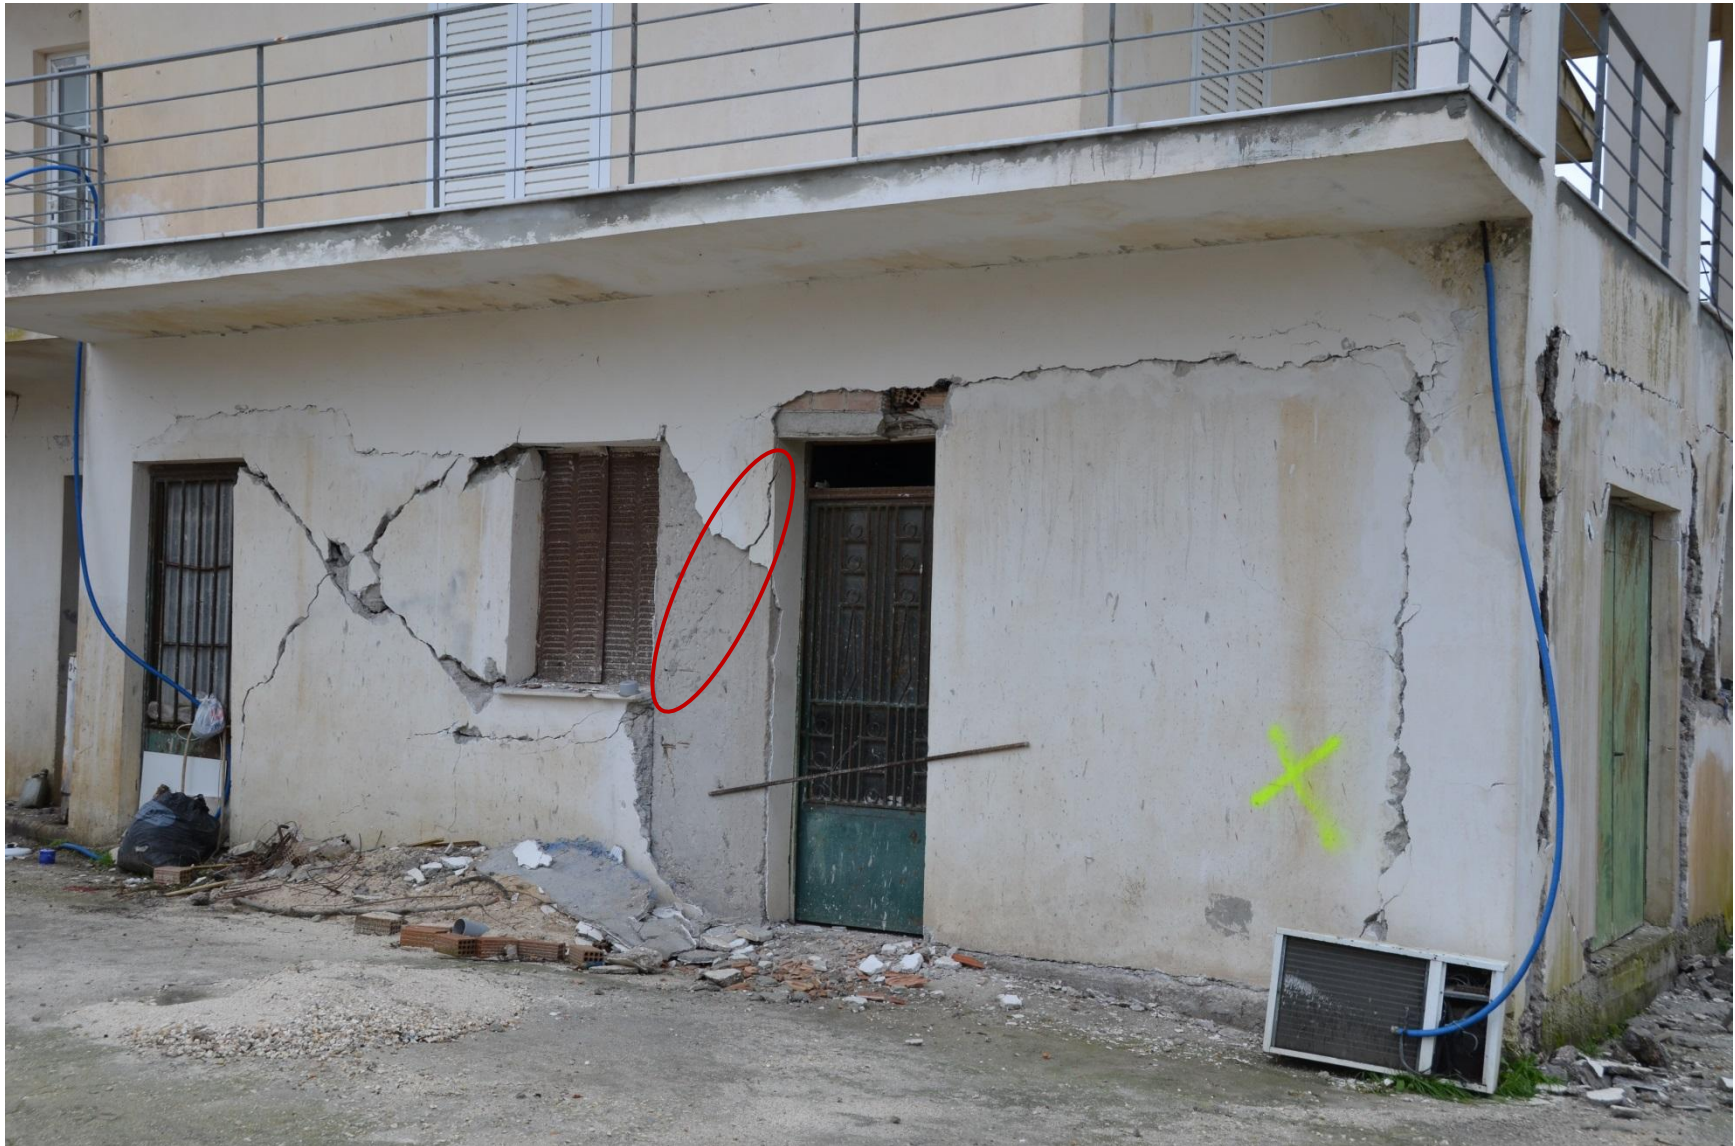
**Photo 5.** Damaged two-story building at Agios Dimitrios after the first earthquake of Jan. 26: shear failure at the central RC column of the façade (left of the door) and X-shaped shear cracks of infill brick walls.

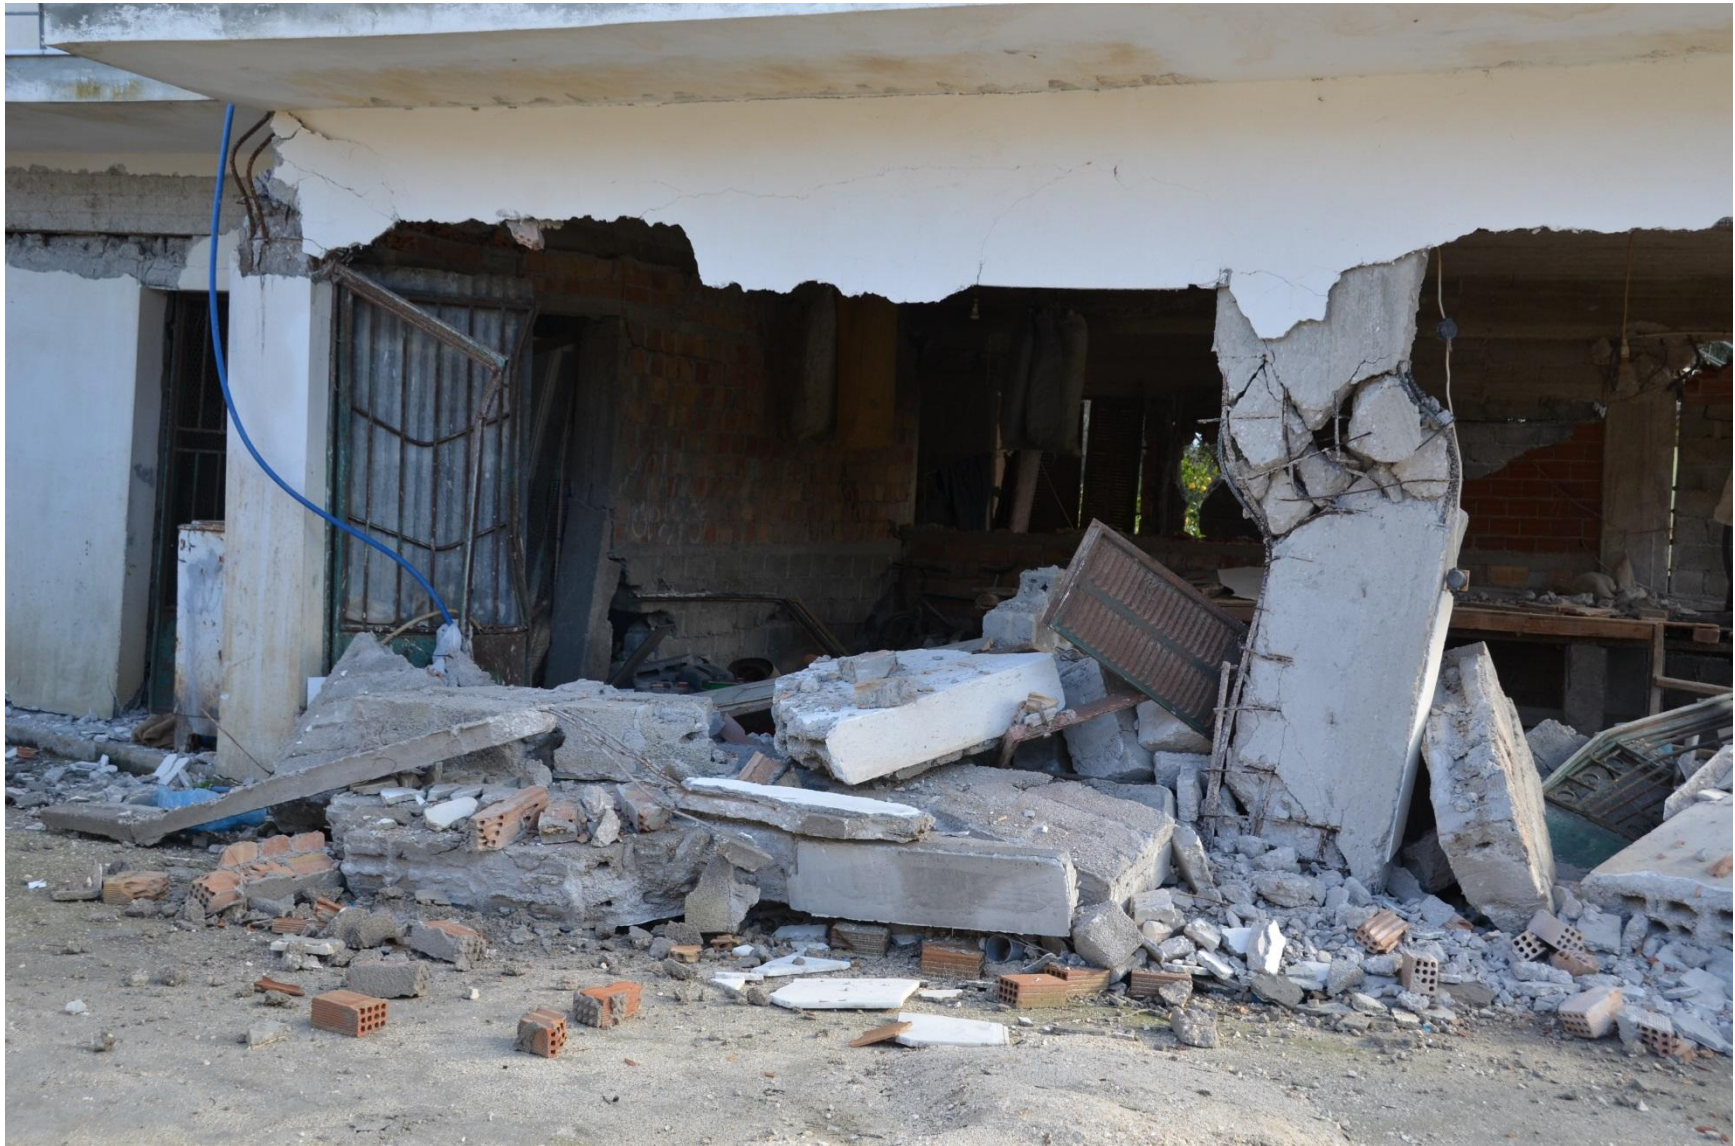
**Photo 6.** View of the façade of the building of Photo 5 after the second earthquake of Feb. 3: the central column suffered severe damage around the pre-existing shear crack while the infill walls totally collapsed.

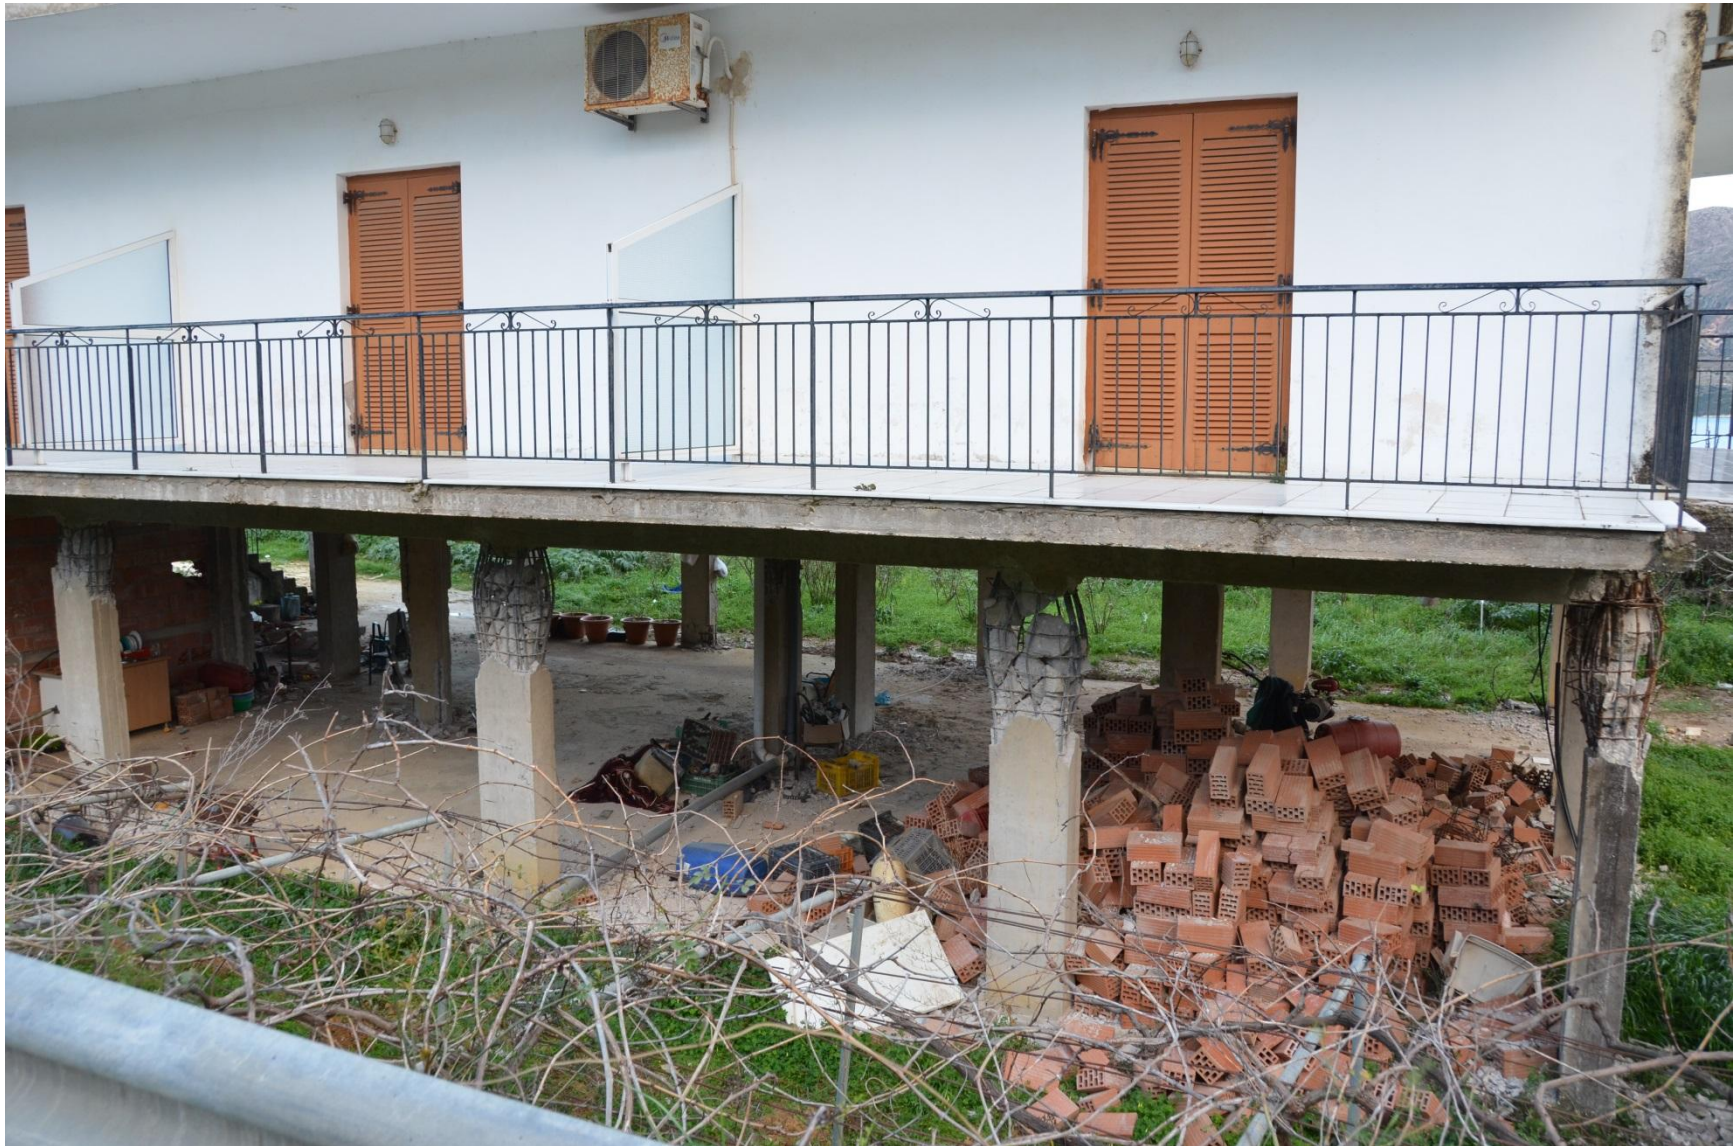
**Photo 7.** Severe damage to the columns of the 'soft' ground floor of a two-story building at Agios Dimitrios after the second earthquake of Feb. 3. The 'stiff' upper floor suffered no evident damage.

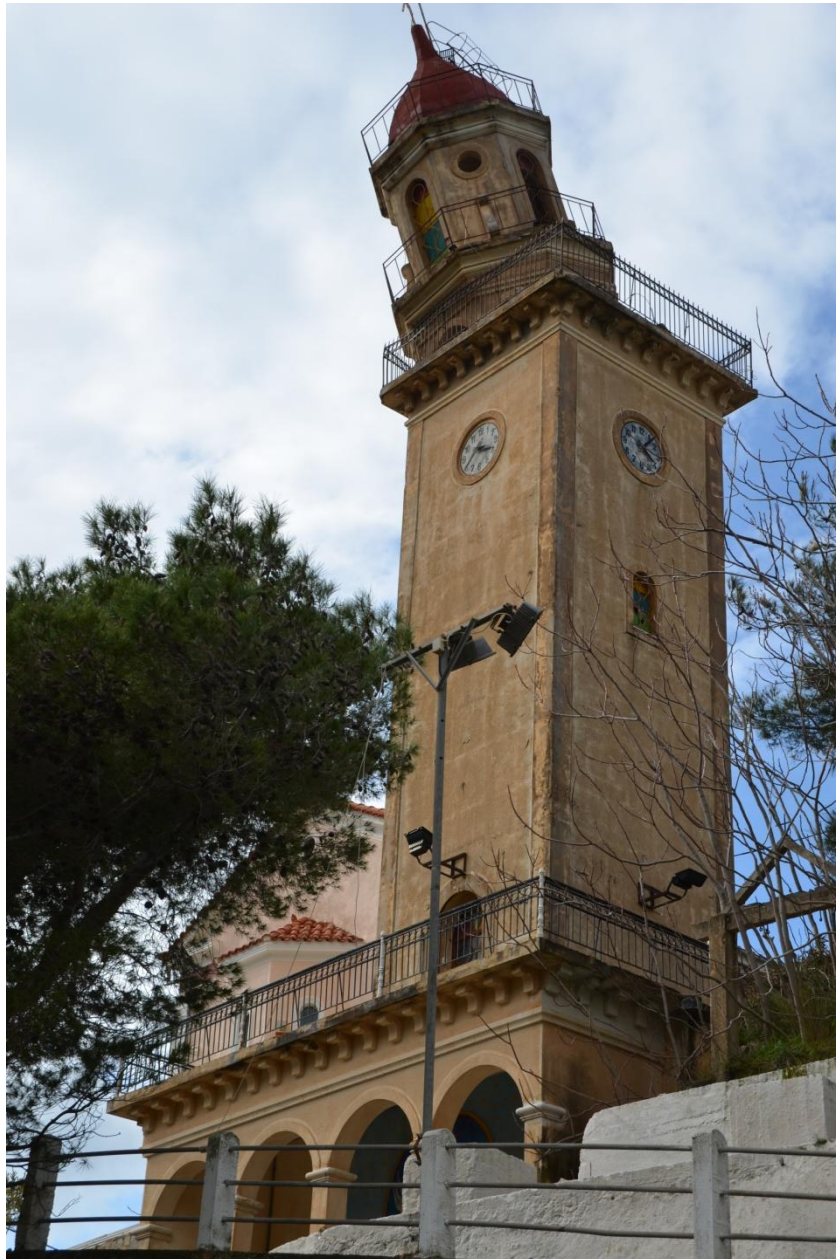
**Photo 8.** Collapse of the RC columns at the upper part of a bell tower at Kourouklata after the second earthquake of Feb. 3. The lower part of the tower had strong infill brick wall and survived the ground shaking without any damage.

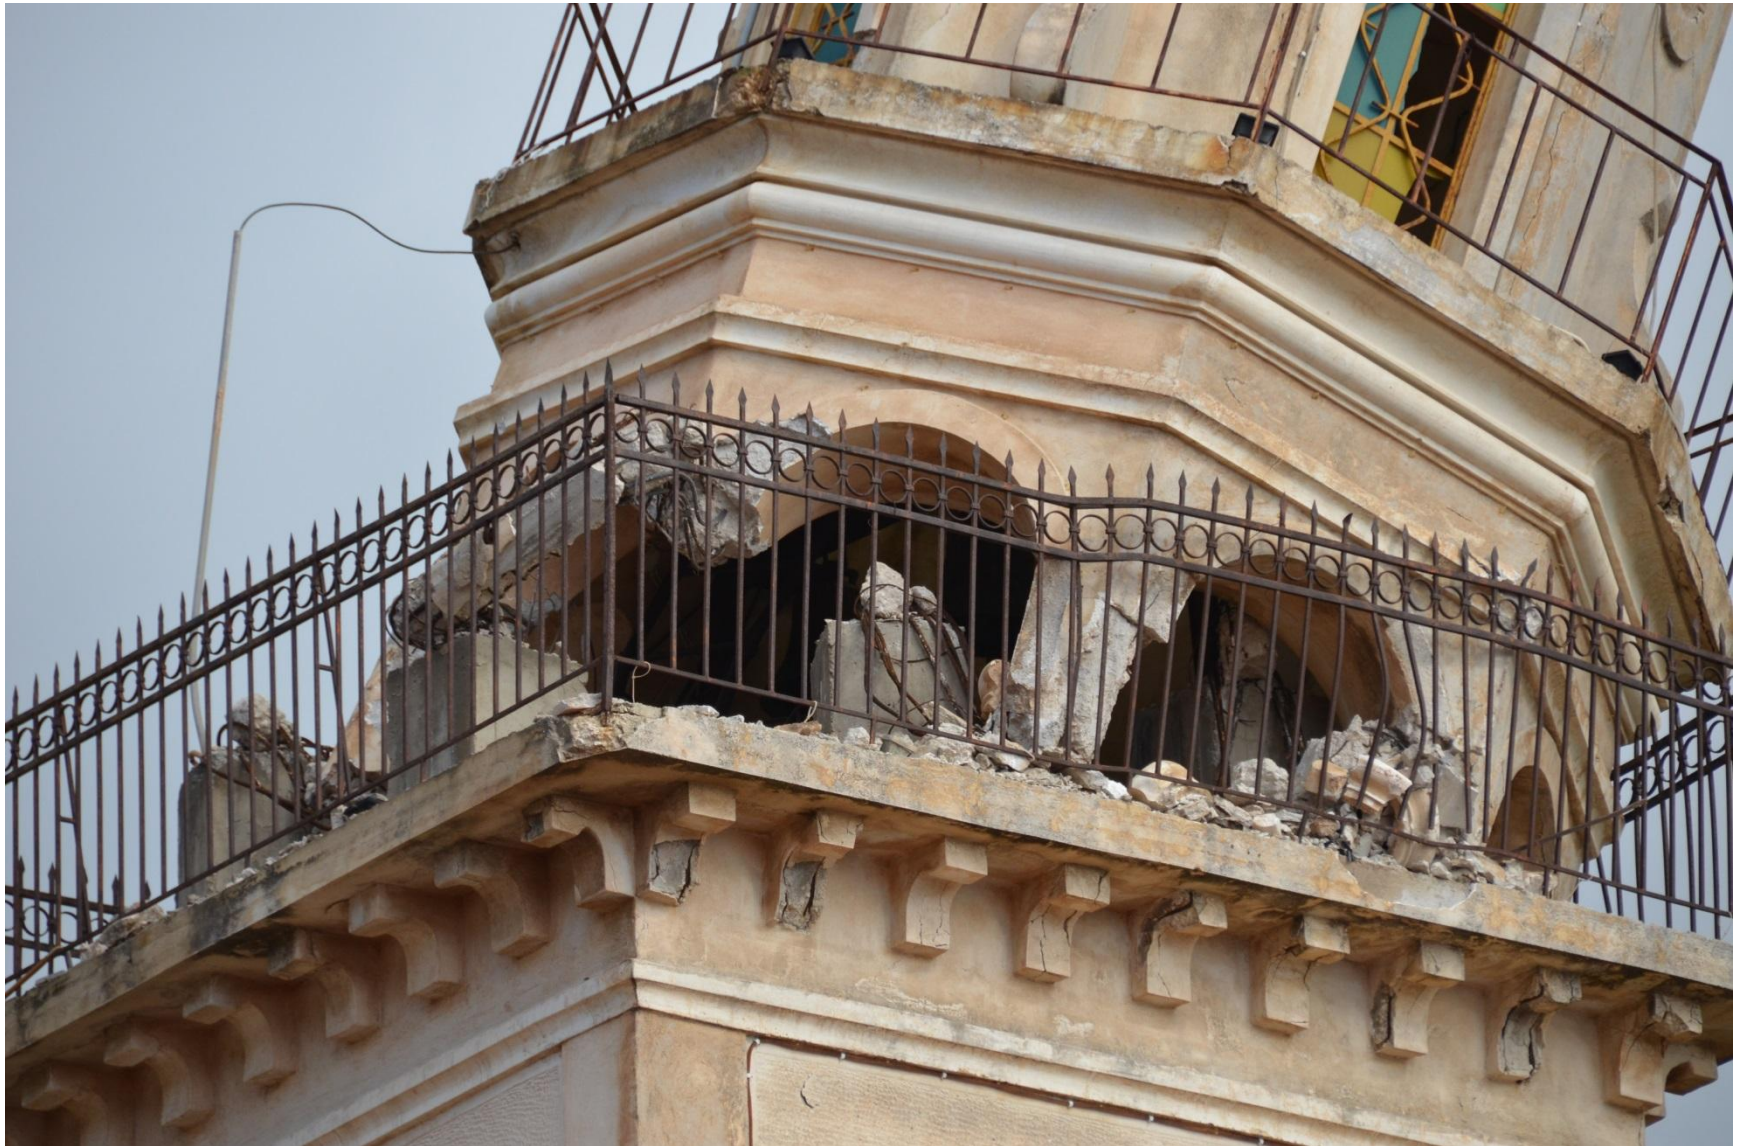
**Photo 9.** Detail of the collapsed columns of the bell tower of Photo 8.

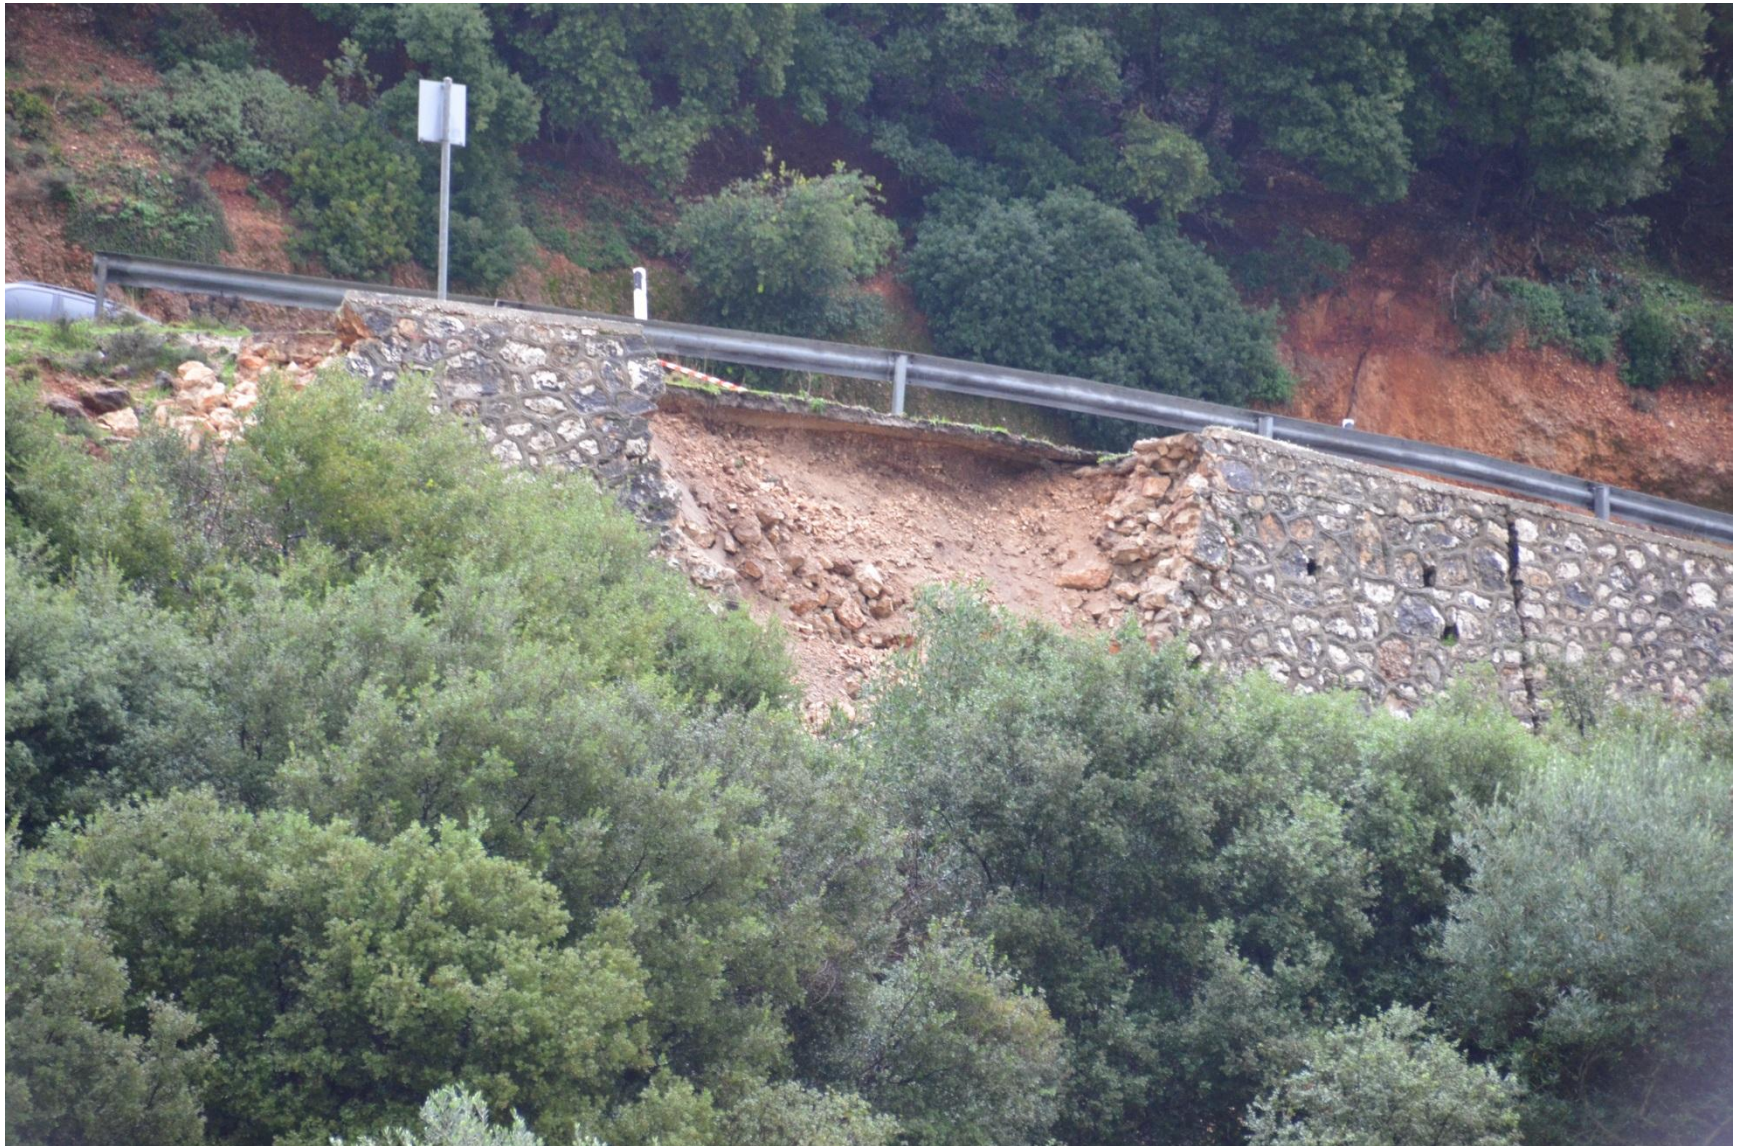
**Photo 10.** Collapse of an old masonry retaining wall at Kritonou.

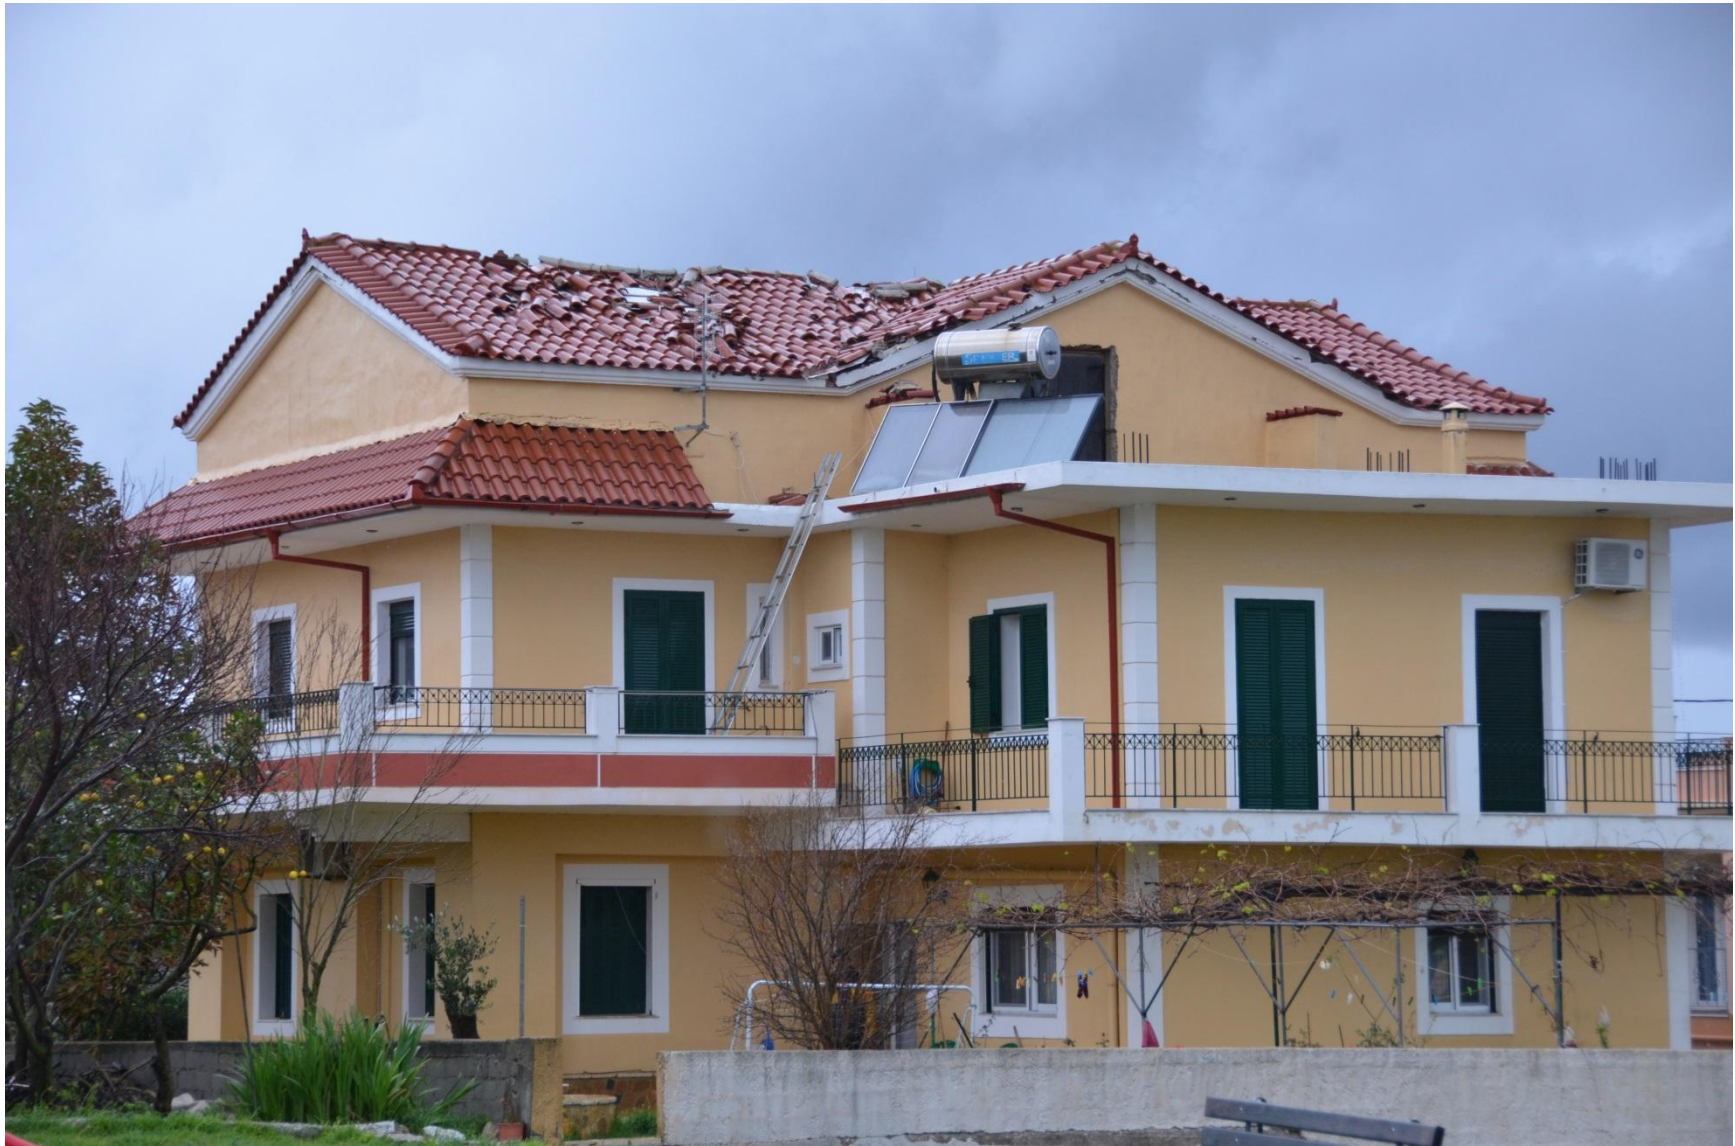
**Photo 11.** The majority of the houses in the epicentral region suffered no evident damage, or damage to non-structural elements only, caused by the large accelerations developed. Typical non-structural damage was the dislocation of roof tiles.

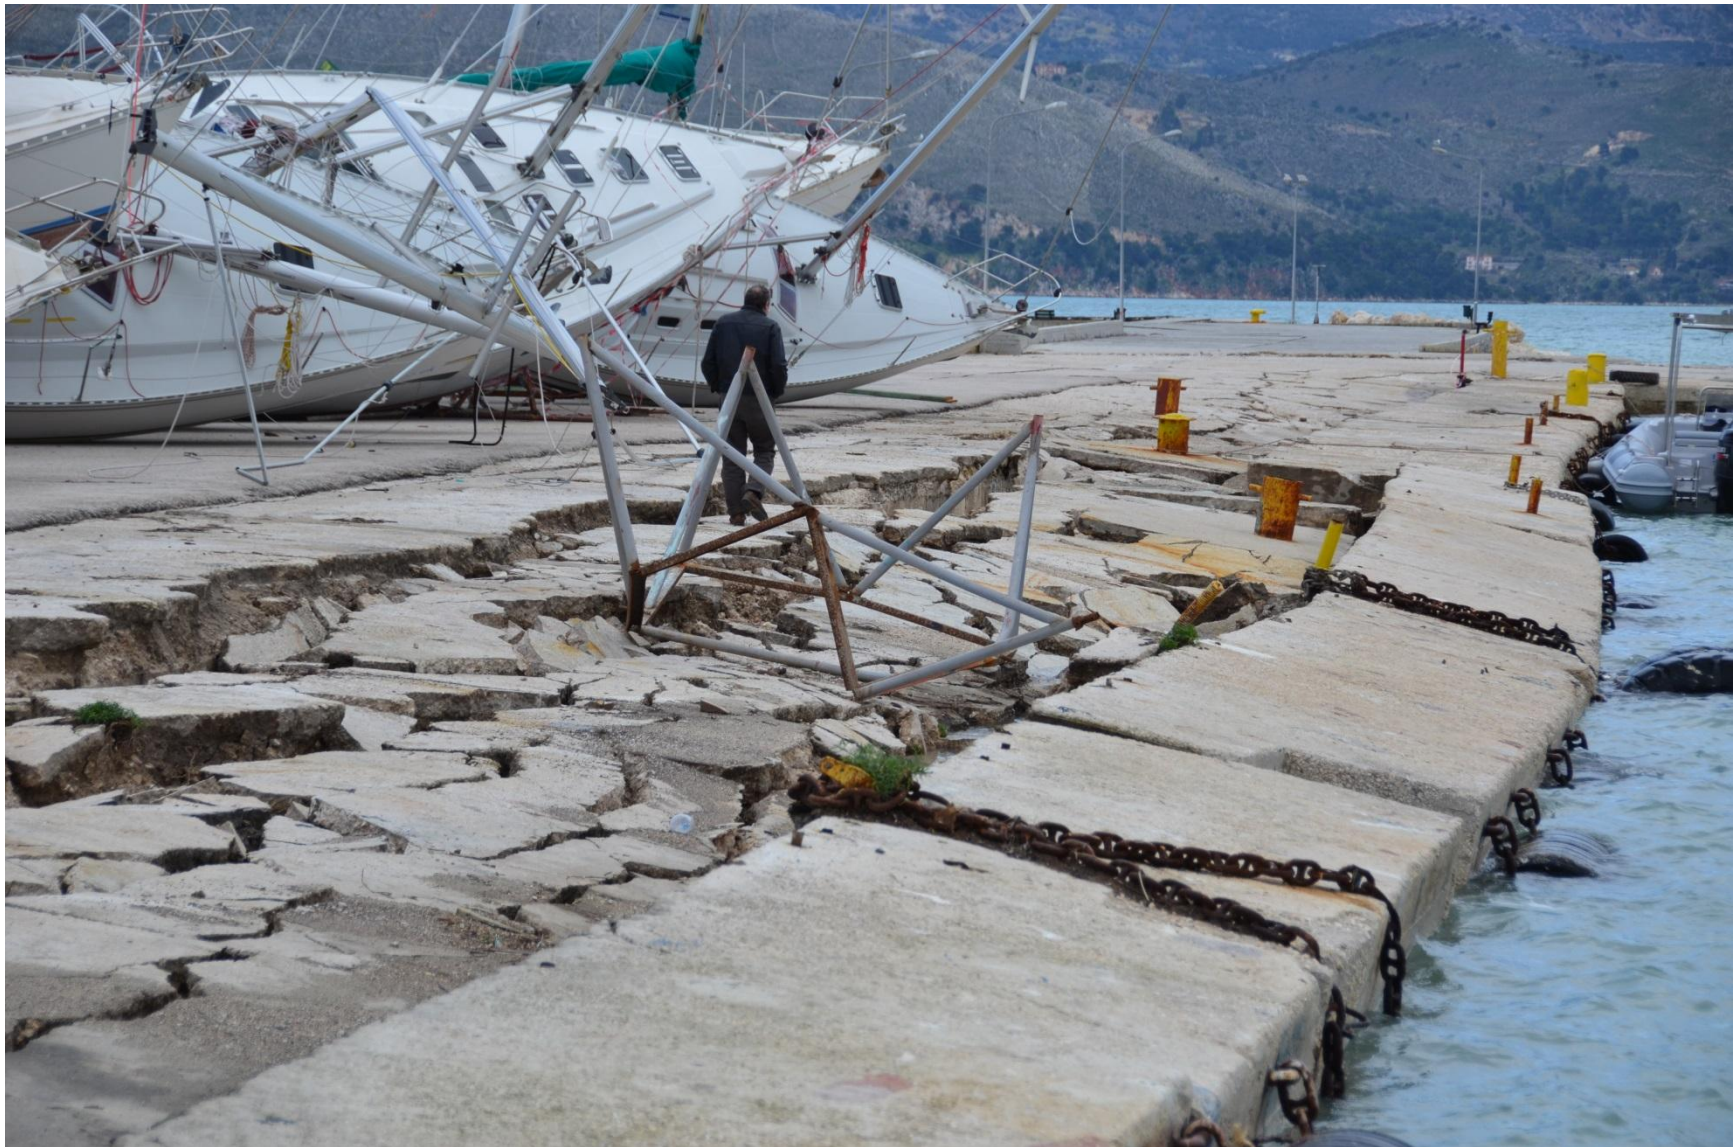
**Photo 12.** Extensive damage to the quay and inclination of the stones of the waterfront at Lixouri after the second earthquake of Feb. 3. The damage caused to the harbor by the first earthquake of Jan. 26 was very small.
