# ***Geotechnical Effects of the 2015 Magnitude 7.8 Gorkha, Nepal, Earthquake and Aftershocks***

## **ABSTRACT**

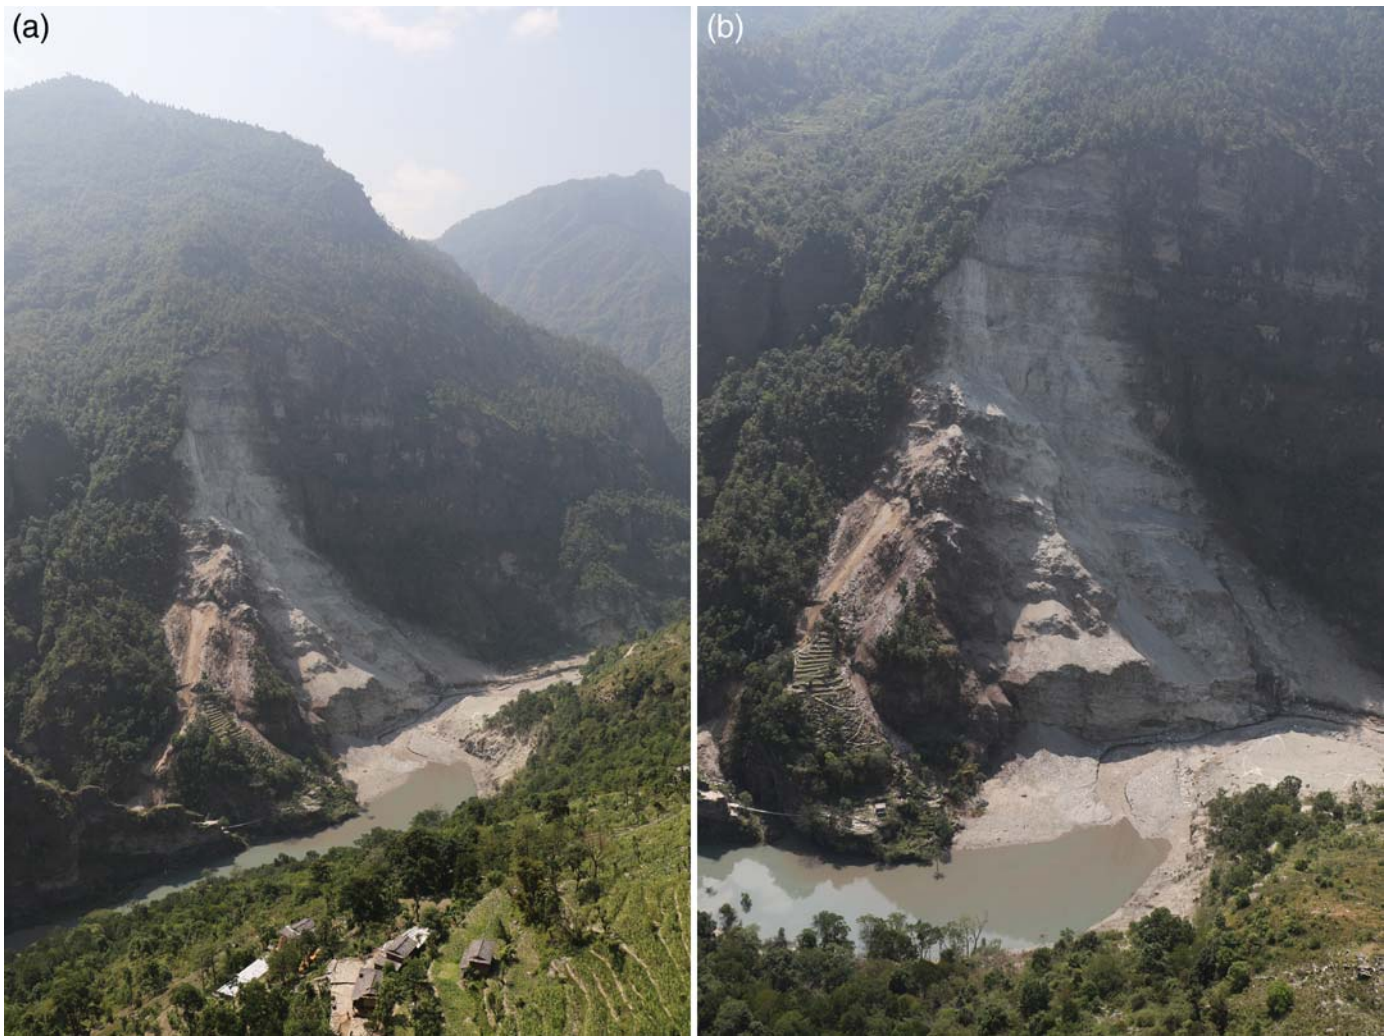
▲ **Figure 4.** Rock slide ( $28.4026^{\circ}$  N,  $83.6017^{\circ}$  E) along the Kali Gandaki River on 24 May 2015 that buried the village of Baisari and blocked the flow of the river for 16 hours nearly one month following the main earthquake shock (a,b). Progressive failure of the nearly 350-m-tall rock mass through the weathered bedrock profile is thought to have led to its eventual collapse. Reproduced from [Collins and Jibson \(2015\)](#).

Several important valley-blocking landslides also occurred, the most notable of which buried the village of Baisari on the Kali Gandaki River (Fig. 4; 28.4026° N, 83.6017° E) several weeks after the mainshock. The rockslide at Baisari, with an estimated volume of 300,000 m<sup>3</sup>, failed progressively. According to interviews with members of the Nepal Army, cracks were observed in the cliff following the April 2015 M 7.8 earthquake, and these cracks widened during the M 7.3 earthquake on 12 May 2015. Ten days later, rocks began falling from the

cliff, prompting evacuation of Baisari. Two days after that, at about 1:00 a.m. local time on 24 May, the slope above the river failed; the resulting landslide dammed the river and buried the entire village, including 27 homes, under about 30 m of landslide debris. The lake overtopped the dam 16 hours later. Authorities were able to evacuate the downstream villages just prior to its failure.

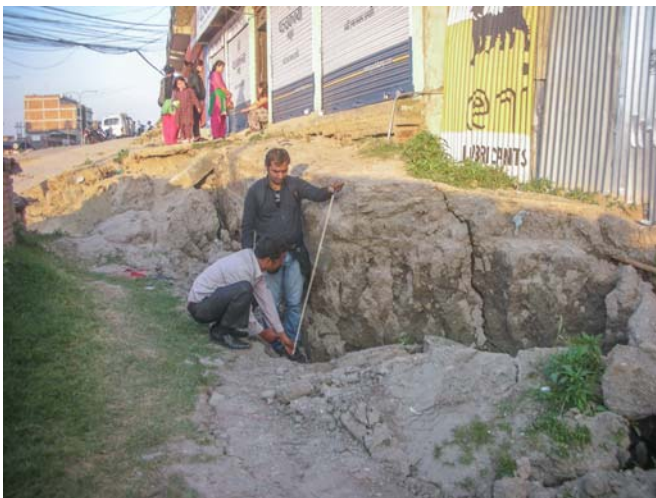
▲ **Figure 5.** Measurement of one of the locations having the largest offsets that was observed in the Lokanthali area along the Arniko Highway ( $27.67439^{\circ}$  N and  $85.36267^{\circ}$  E).

Many of the soil-failure sites liquefied, as indicated by the presence of sand boils (e.g., Manamaiju, Bungamati, Changuarayan, and Mulpani). However, an interesting ground failure occurred along the Arniko Highway in Lokanthali ( $27.67439^{\circ}$  N,  $85.36267^{\circ}$  E), where lateral cracks having 2-m-deep fissures and as much as 1.5 m of nearly vertical offset occurred over a large area on or near ground sloping toward a river channel (see the photo in Fig. 5 and a map of the fissures in Fig. 6). The lack of evidence for liquefaction, reports that the failure progressed slowly, and the observation that the slip surface extended into the weak black cotton clay led to an initial assessment that these failures resulted from cyclic failure (i.e., structural breakdown of clay particles) in the black cotton clay, for which lab tests indicated moderate sensitivity and a liquidity index greater than one. Subsequent trenching and hand-
