In the Dseskasgan Area (Kazakhstan), copper is mined since decades under difficult geotechnical conditions using the room and pillar method. In this work the stability of pillars in inclined mining as well as in retreat mining with 30 m high rooms will be analysed.

Kammer-Pfeiler-Abbau (Kupfer) Abbau in horizontaler und geneigter Lagerung

Leiter: Prof. Dr.-Ing. habil. H. Konietzky
Bearbeiter: Dipl.-Ing. Falko Schmidt

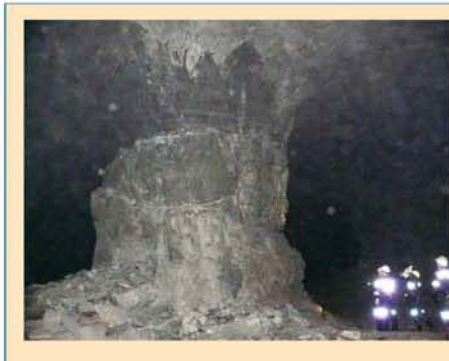
The mining is modelled in 500 m depth. Six pillars with an system area of 20 x 20 m and two barrier pillars are illustrated. The pillar height is 8 m.

This decomposing phenomenon observed on the pillars in the mine could be explained by stress and plasticity states. The compression stress in the pillars was orientated perpendicular to the mining.

Variants with mining inclinations of 15°, 30° and 50° were calculated and the load in the pillar registered. Pillars not orientated to the mining showed clearly lower bearing capacity, caused by "flaking off".

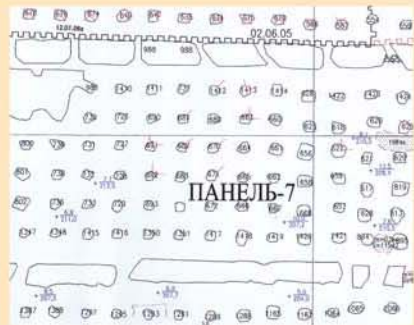
Stability analysis and "Flake off" phenomenon on pillars

Geomechanical stress situation is influenced by extremely high lateral stresses. Caused by the inclination of the mining an orientation of the pillars by "flaking off" is observed.

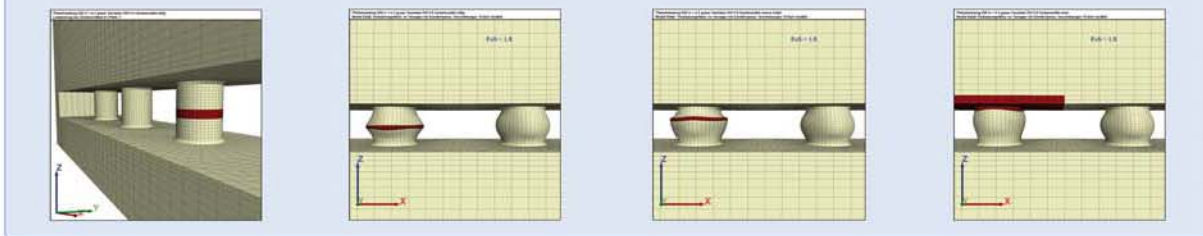
Mining retreat with 30 m high mining rooms

Pillars in old mining areas do have a high copper content and therefore attractive for mining. The pillar volume is 25% of the total volume. The feasibility of a room and pillar retreat mining is investigated. Pillars are retreated successively. After the retreat of the 2nd pillar row, stability is affected negatively, since the load can be beared partial by the barrier pillars. After retreating the 3rd pillar row, the collapse of the roof is initiated by mayor displacements, whereby the collapse is limited on the area without pillars.
