**RETAINING STRUCTURES – INTERNATIONAL DESIGN  
AND BUILD COMPETITION COURSEWORK**

**Title:** Design and evaluation of soil-nailed earth retaining wall supporting a sandy backfill.

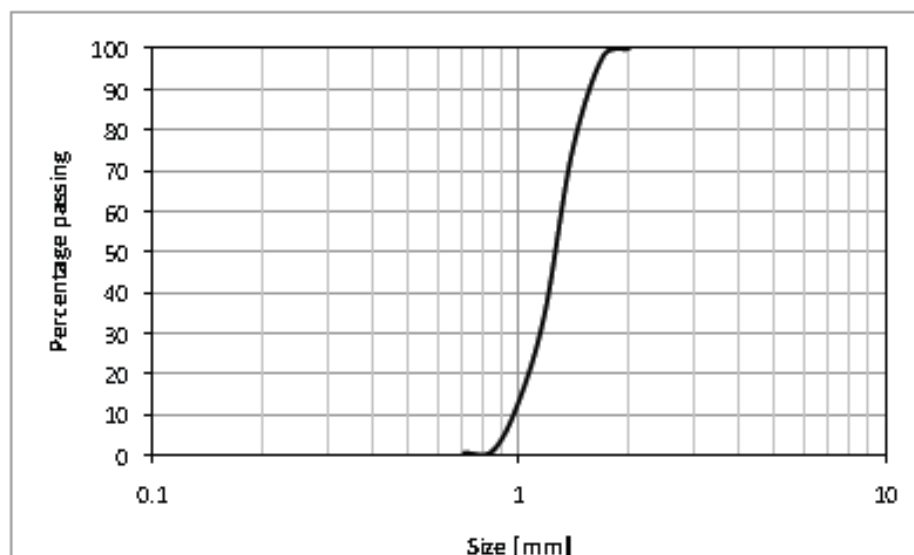
Figure 1.0- Particle size distribution of soil sample S1

Soil sample S1- Leighton buzzard silica clean dry sand, grade 10/18. Particle size distribution illustrated in figure 1.0.

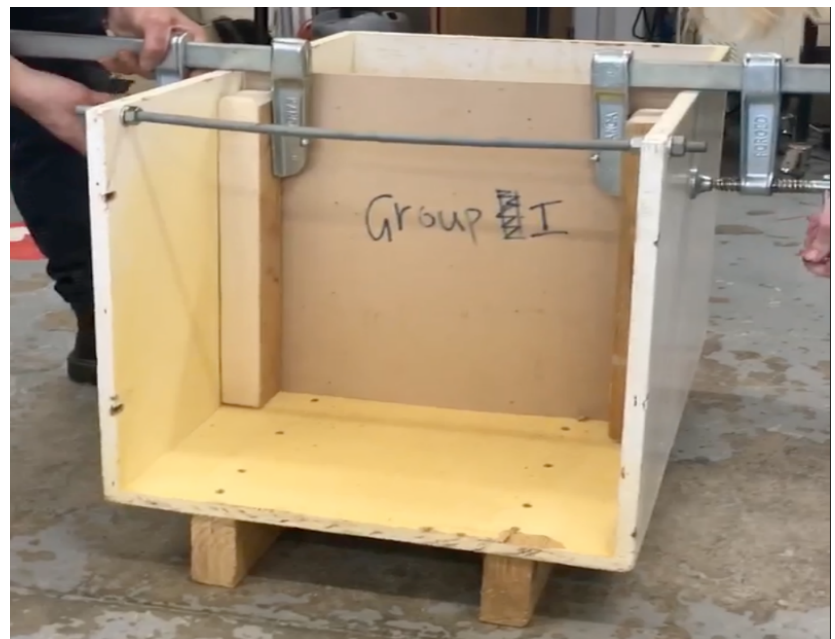
Figure 5.0 Soil Nailed Retaining Wall Napier's Design

Retaining Wall- Plywood

Nails- rope/cord/string

Anchor- cotton wool balls

The reasons for the selected approach was based on the design layout of the three vertical piles at the front elevation. The piles provide stability and strength to retain the soil backfill. The addition of the soil nails combined with the anchors provides stability and lateral support, to counteract the lateral forces pushing on the retaining wall and to help withstand surcharge loadings.

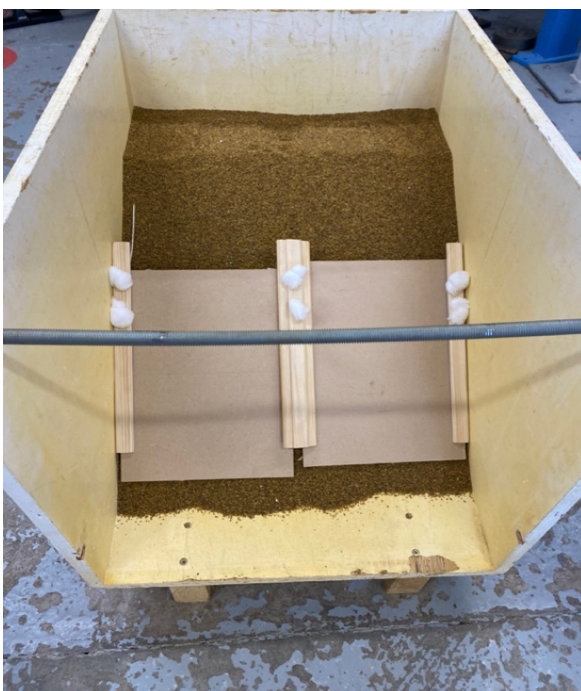
Figure 13.0 Failure of the retaining wall built

The retaining wall failed to withstand the self-weight of the soil backfill as soon as the clamps were loosened from either side of the wall thus resulted in slope failure. A source of error that could have potentially led to failure of the wall, was the orientation of the reinforcement.

Failure of the retaining wall when both clamps were loosened

The reinforcement was supposed to be at the bottom of the wall as opposed to the top, as seen in the photos below. This error could have occurred due to misinterpretation of the conceptual design layout and the miscommunication from the students to the lecturers clarifying the design measurements.

The failure plane of the retaining wall represented a rotational slip surface where the reinforced earth used the reinforcement as a pivot angle to overturn the retaining wall from the bottom. The active pressure exerted by the retained soil overpowered the lack of passive pressure from the reinforcement, failing to counteract the overturning of the retaining wall resulting in failure.

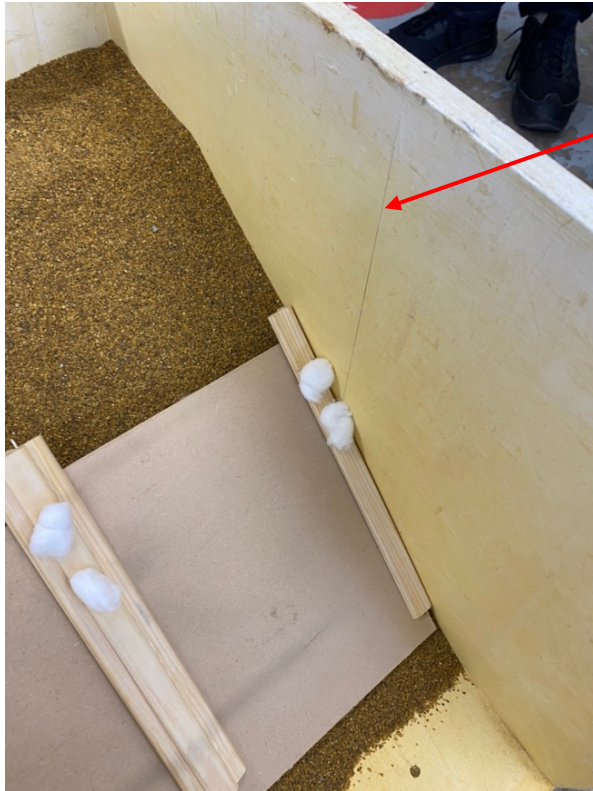
Figure 14.0 Location of the retaining wall before failure

Figure 14.0 displays the slip surface of the reinforced earth. The pencil mark outlined by the red arrow is an indication of the original location of the retaining wall prior to the clamps being loosened.

This shows the distance travelled by the wall and soil due to the exerted forces of the retained soil on the wall.
