## PRELIMINARY REPORT ON DAMAGE AT CEPHALONIA ISLAND IN COLLABORATION WITH GEER ASSOCIATION

By: Kiki Dimitriadi, Geotechnical Engineer, Geoengineer.org

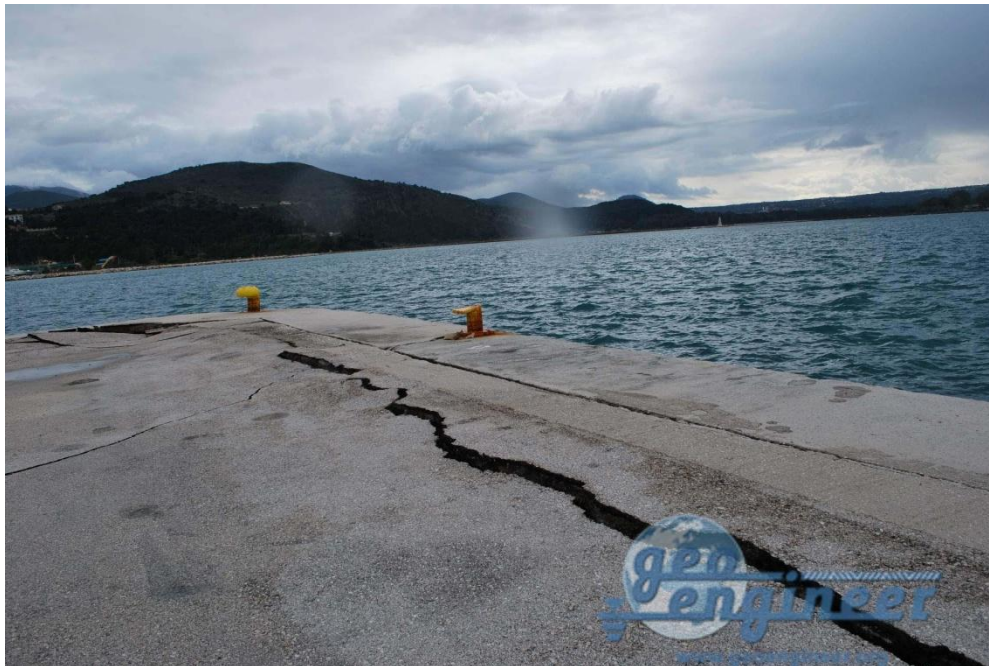
**Picture 1:** Port of Argostoli\_1

At the port of Argostoli, (**Picture 1 - 3**) sand boils and relatively narrow surface cracks, are observed, in the order of 5-10 centimeters, due to liquefaction and liquefaction induced lateral spread. Horizontal displacements increased from the landside to the waterfront of the port reaching half a meter in total in some locations. Vertical offset is estimated to be around 10cm.

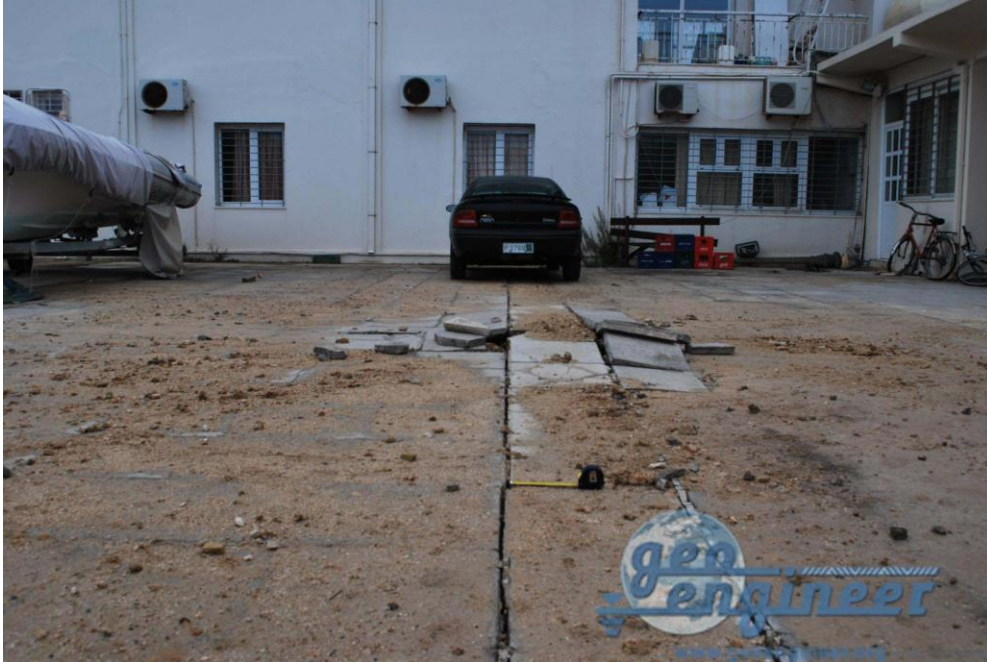
Picture 2: Port of Argostoli\_2

were no larger than 30 cm. Thus, separating the two events will be key. The strong motion station positioned in the port of Argostoli by the Geotechnical Laboratory of the University of Patras following the first earthquake has recorded the February 3<sup>rd</sup> earthquake event (with approximate PGA of 0.42g), and will be key in analyzing this case history. There was pronounced liquefaction around the position of the ground motion station (see also **Picture 2**).

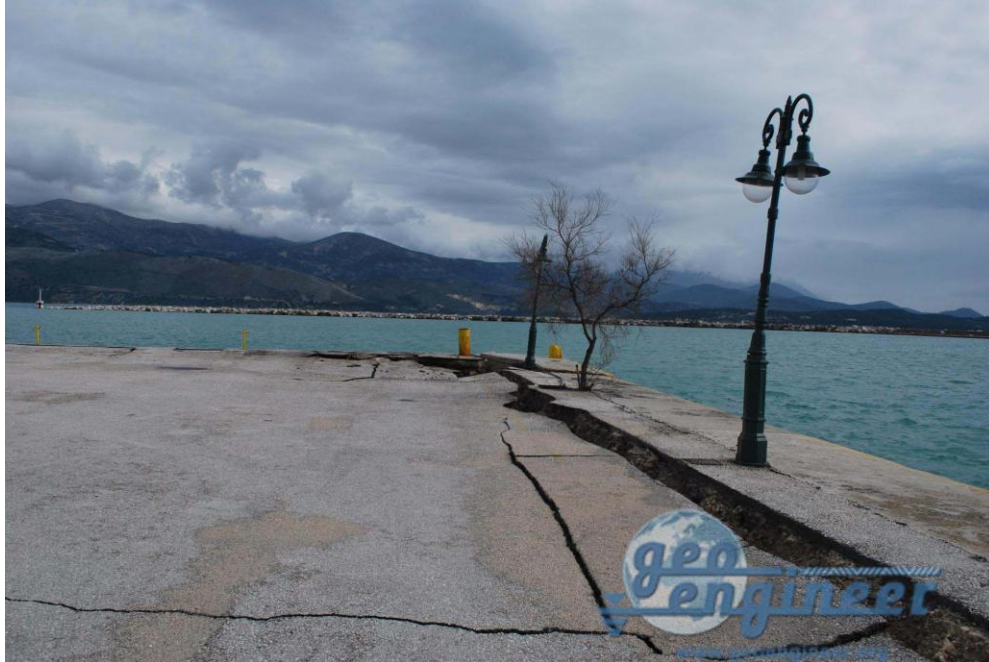
Picture 4: Port of Lixouri\_1.

The port of Lixouri (**Picture 4 – 8**) is significantly damaged with extensive cracks due to liquefaction induced lateral spread. According to our measurements displacements reached 55cm in the parallel to the waterfront direction and 35cm in the vertical direction. Vertical offset was measured around 20cm. In other locations of the port, horizontal displacement reached roughly 80cm. Liquefaction and lateral spread phenomena are observed mainly in the older part of the port, which consists of poorly compacted fill material, according to local engineers. The jetty (made of rip-rap) at the entrance of the port did not appear to have been significantly affected by the earthquake (**Picture 8**).

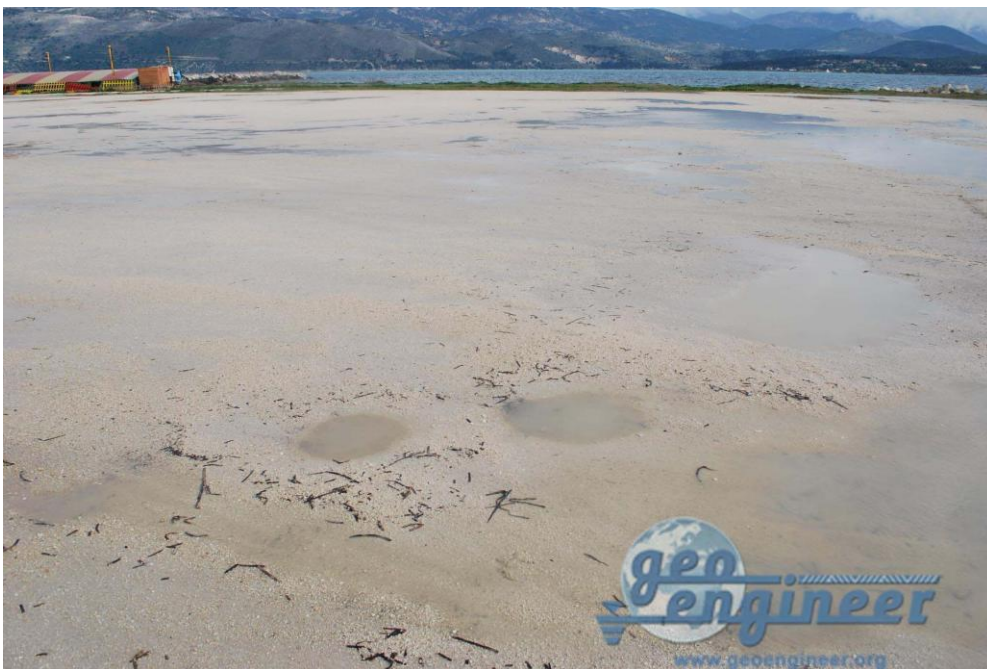
Evidence of liquefaction is observed along the coastline of the town of Lixouri, in the form of liquefaction sand boils (**Picture 9 – 11**) with diameter in the order of 50 cm. A few meters away from the particular location, the liquefied material has been ejected through the soil cracks and is now exposed on the soil surface (**Picture 12**).

**Picture 9:** Liquafaction craters\_1 (Lixouri).

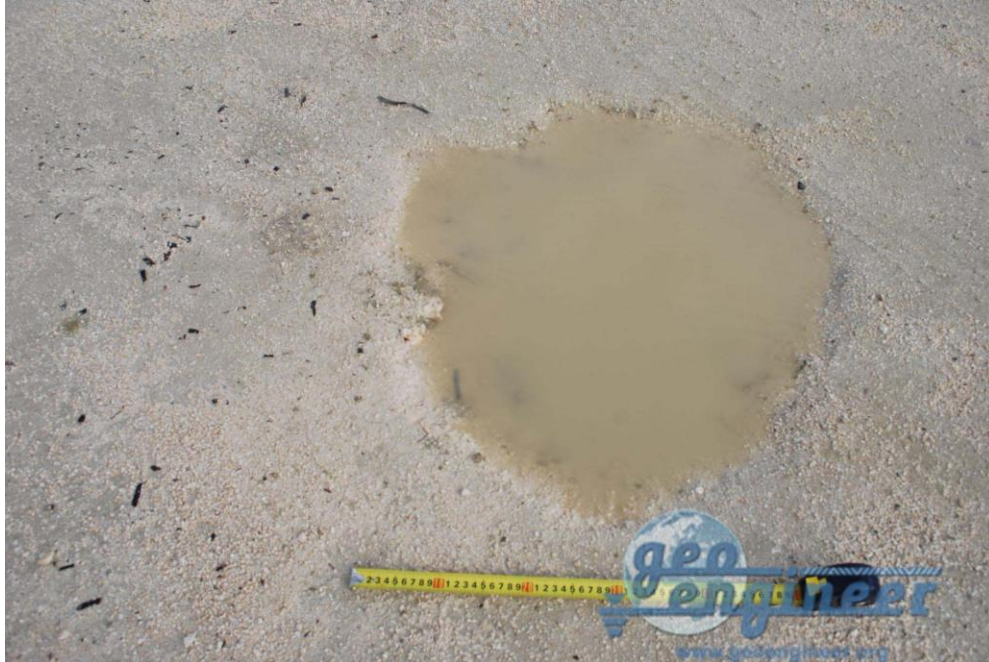
**Picture 10:** Liquefaction craters\_2 (Lixouri).

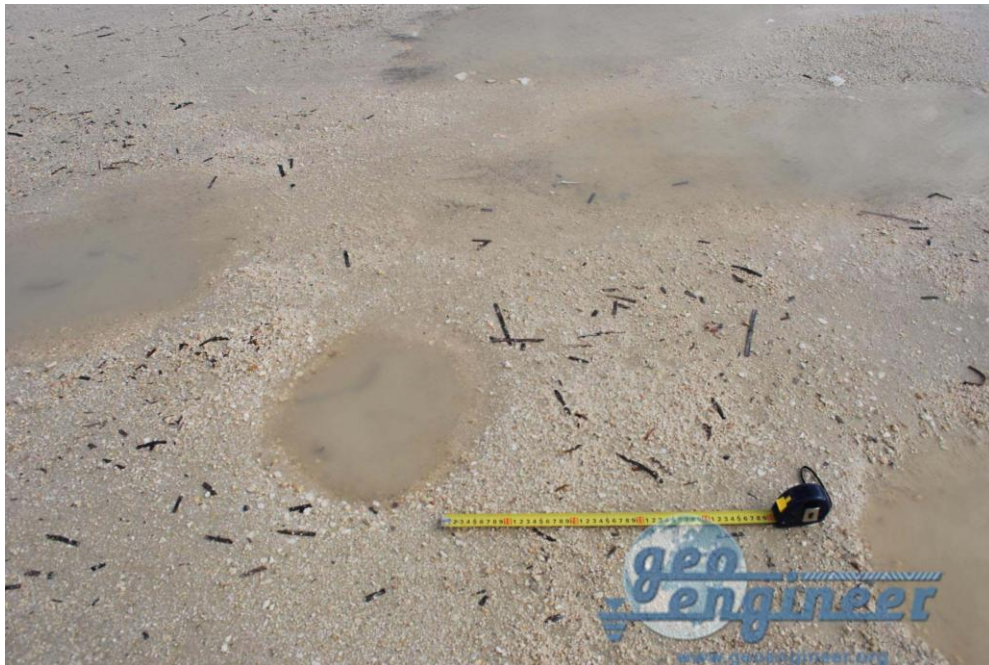
**Picture 11:** Liquefaction craters\_3 (Lixouri).

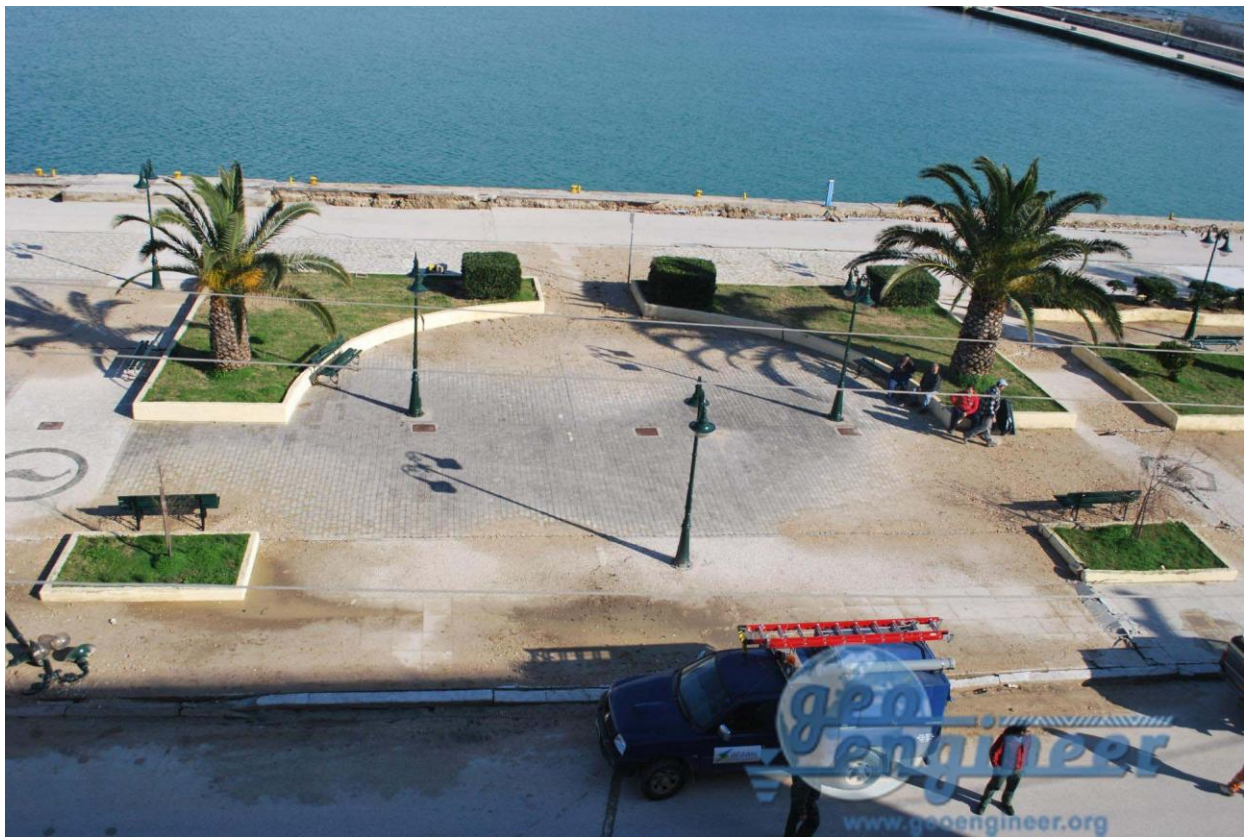
**Picture 12:** Indications of liquefaction (Corner of Laskaratou & Skarlatou, Lixouri).

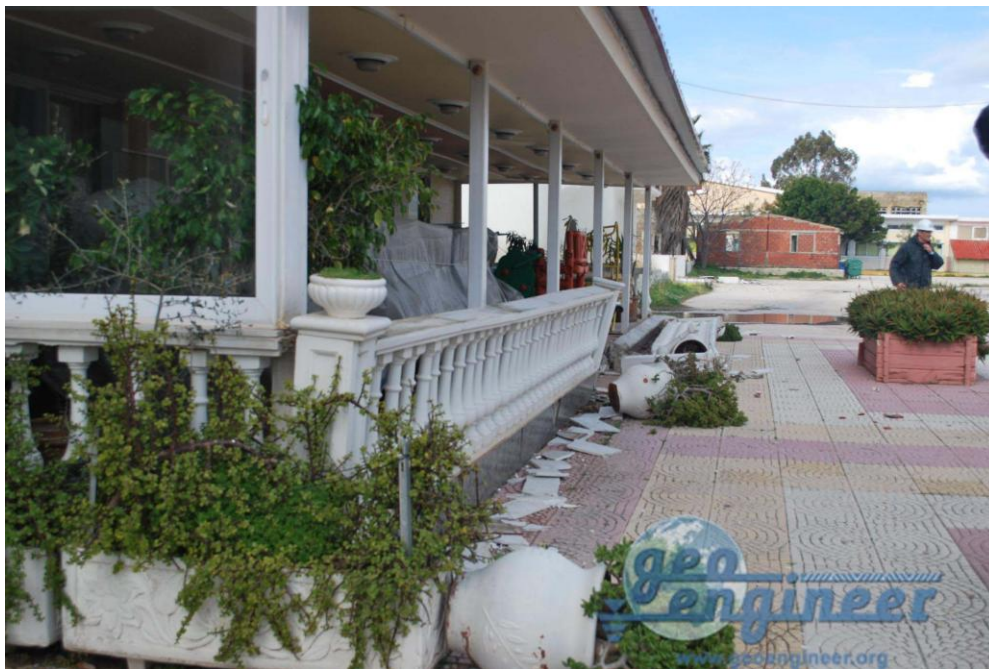
**Picture 13:** Summery Hotel\_1 (Lixouri).

Additionally, along the coastline of the town, Hotel Summery has undergone some damage. We were not able to inspect the interior of the building, however important evidence regarding the directionality and intensity of the motion are provided in **Picture 13**. Evidence on the direction and intensity of the seismic motion are also provided in **Picture 14** taken at the church of Pantokrator, opposite to the City Hall of Lixouri. These issues need to be explored further.

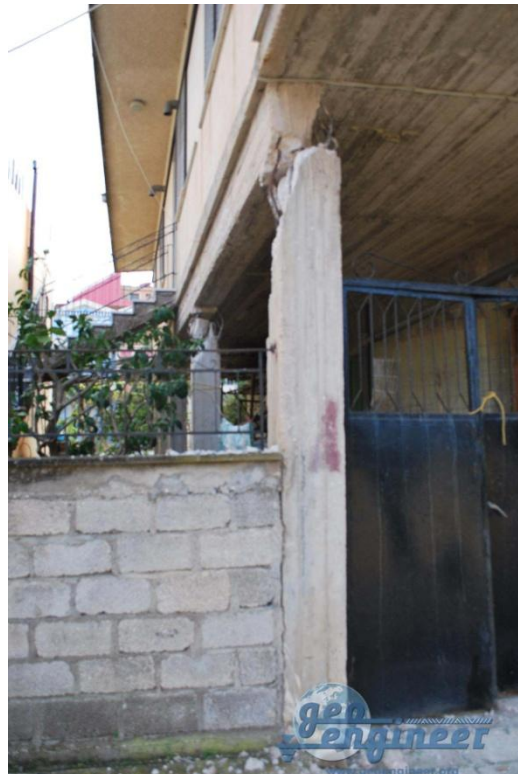
Cases of non-damage include the old school of Lixouri, designed by Prof. Moraitis of NTUA, which has survived the even more devastating seismic activity of 1953 as well as newly built construction, with the exception of classic “soft storey” failures of one-storey building with pilotis as presented in **Picture 15**.

Picture 15: Example of Soft-storey failure
