# Embankment Failures on Soft Clay in Brazil

J.A. Ortigao

## Introduction

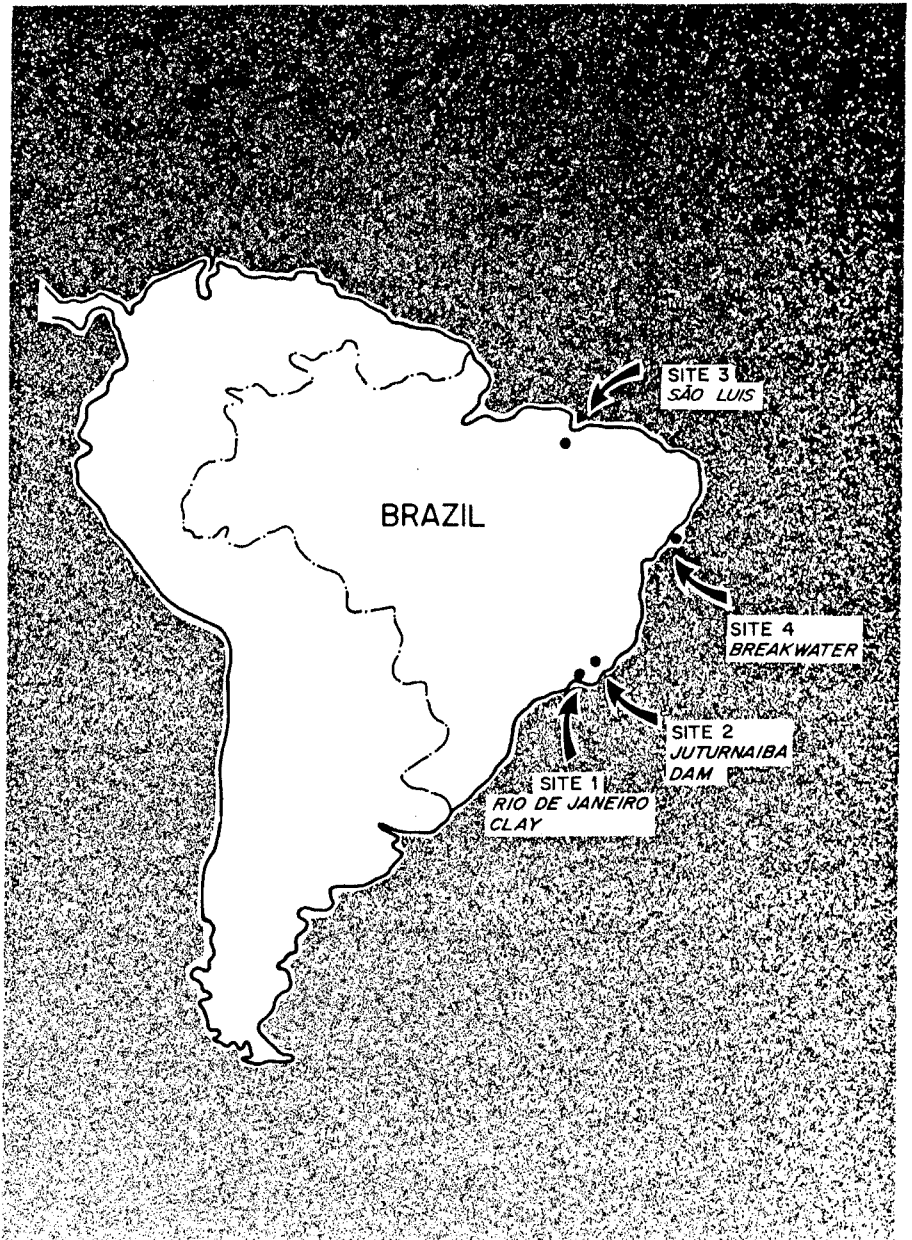
Figure 1 Location of failures

In the last 15 years a few well documented embankment failures have taken place at four different soft clay sites in Brazil (figure 1). The purpose of this note is to present a brief summary of this experience.

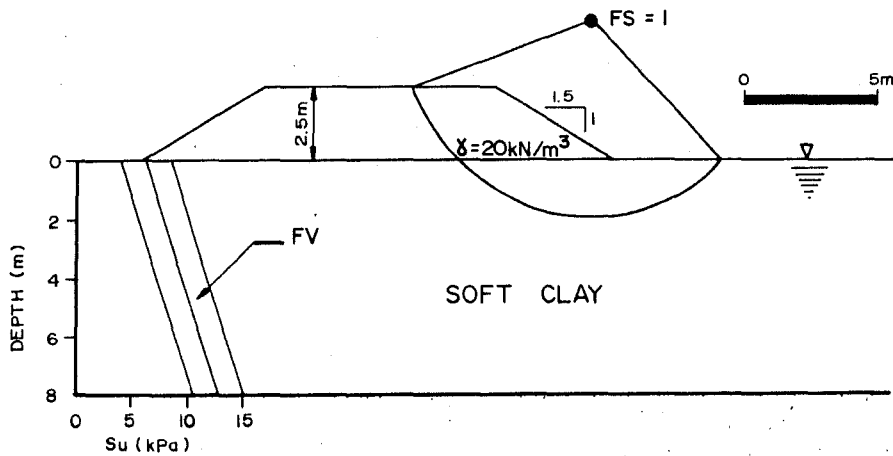
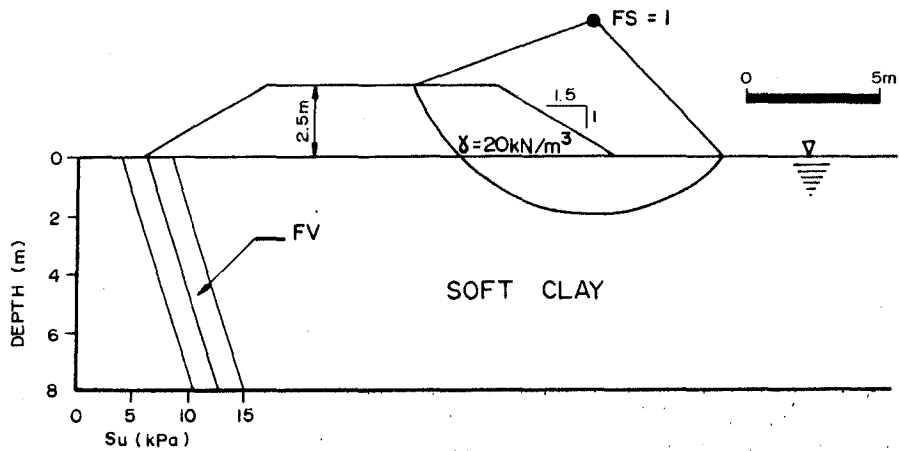
Figure 4 - Case 3 - Railway embankment failure near Sao Luis

Case 3 - Unlike the previous trials, this case was an accidental failure. It took place on a railway embankment that crossed a 20km length of marshy area near the city of Sao Luis. The

embankment design was based on *FV* strength data obtained from 100m spaced boreholes along the proposed railway alignment. But, failure took place on a softer marine design stage (figure 4).

Again, the stability analysis based on detailed site investigation yielded  $PI=50\%$ ,  $LL=90\%$  and  $w=70$  to  $110\%$  and a factor of safety close to 1 for failure conditions and mean uncorrected *FV* profile (table 1).

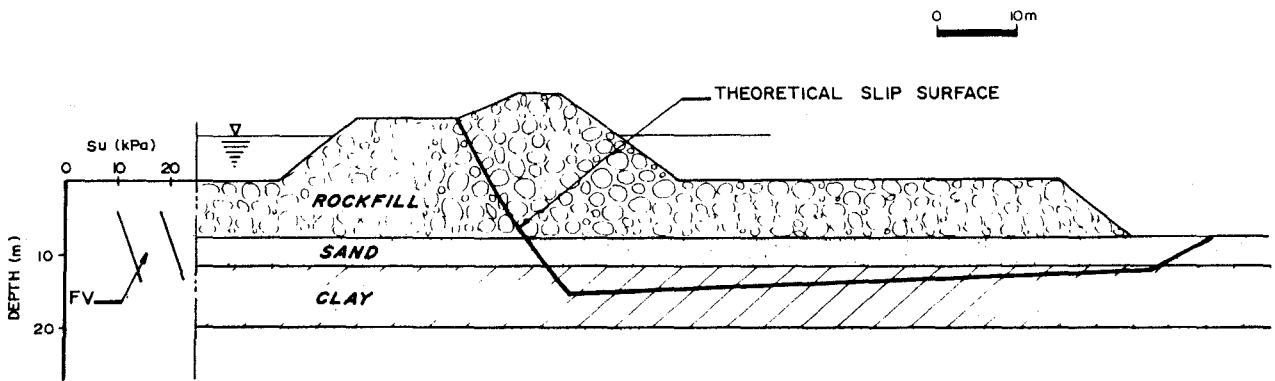
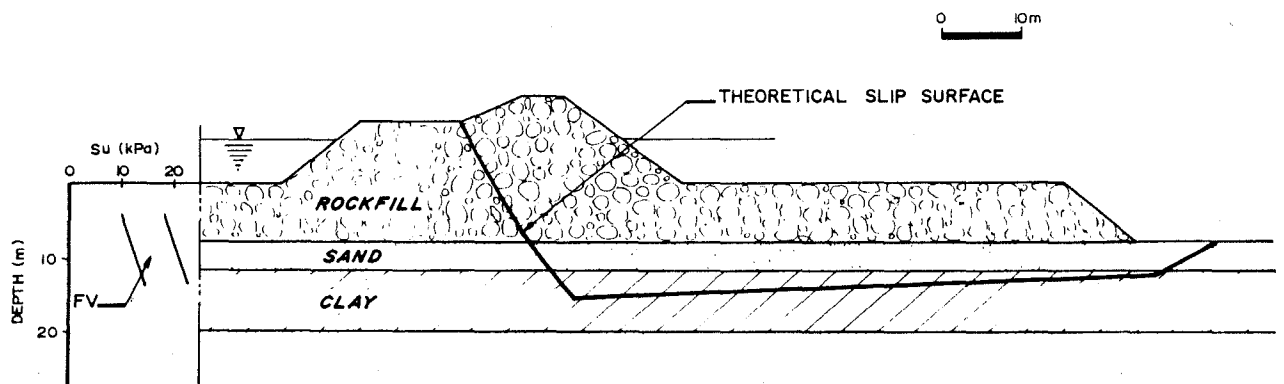
Figure 5 - Case 4 - Failure of a breakwater on soft soil

Case 4 - An end-of-construction failure of a breakwater took place on a soft clay foundation at site 4 (figure 1). The foundation soils consisted of a 4m layer

of fine sand, followed by 8 m of soft clay with *FV* strength ranging from 10 to 20 tkPa. Figure 5 shows a cross section of the breakwater. Post-failure stability analysis used Janbu's simplified method, polynomial slip surfaces and detailed site investigation. Uncorrected *FV* strength data yielded  $FS=0.98$  (table 1).
